**BITHLO/CHRISTMAS
TRAFFIC SAFETY AUDIT
ORANGE COUNTY DISTRICT 5**

**PUBLIC WORKS DEPARTMENT
TRAFFIC ENGINEERING DIVISION**

OCTOBER 2010

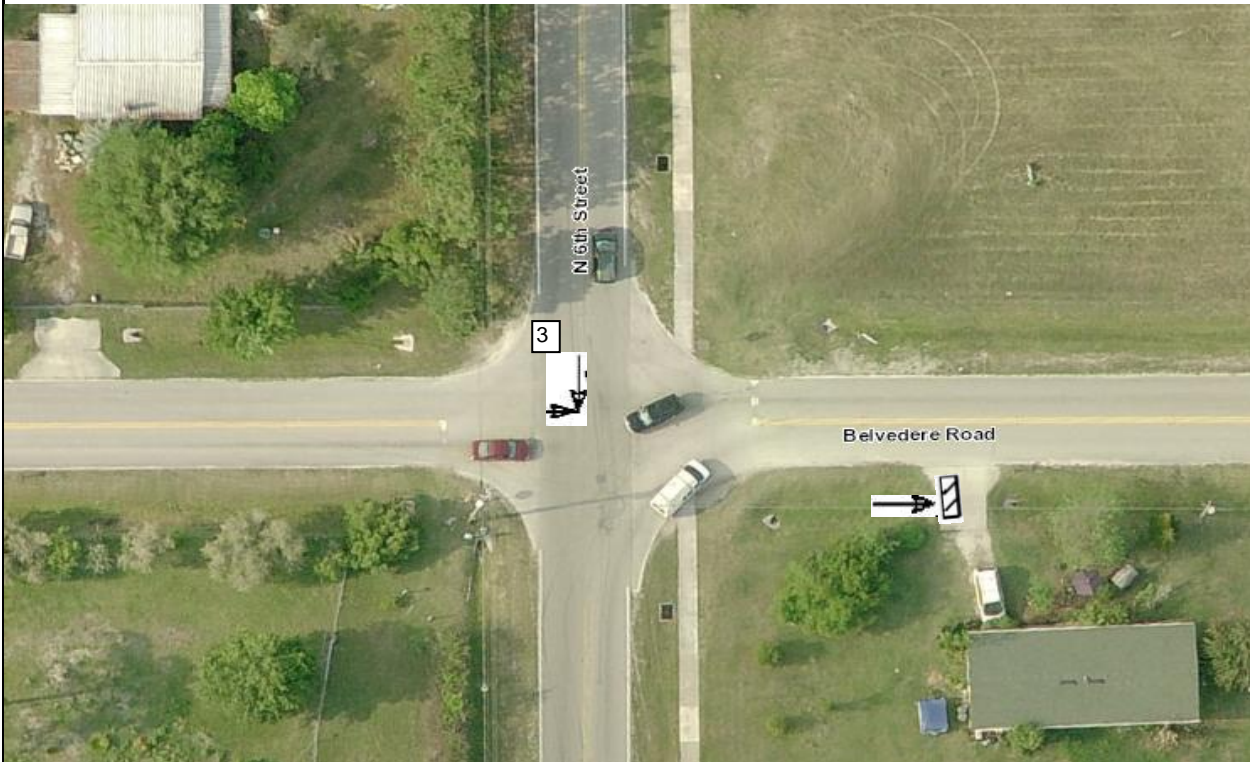
LOCATION ID: Belvedere Road at 6th Street

The right angle crashes at the intersection of 6th Street and Belvedere Road were addressed by replacing the standard size stop signs in the east-west direction with oversized stop signs located closer to the stop bar to better alert drivers of the stop condition. This improvement is detailed in the table for Belvedere Road improvements. Although several citizens at the community meeting requested various improvements such as signalization or installation of an all-way stop, studies were conducted and these improvements were found not to be warranted.

The four crashes reported at the intersection of 6th Street and Belvedere Road are summarized in a table and collision diagram to be found in the 6th Street section of the report.

Again, the right angle crashes at the intersection of 6th Street and Belvedere Road were addressed by replacing the standard size stop signs in the east-west direction with oversized stop signs located closer to the stop bar to better alert drivers of the stop condition. Although several citizens at the community meeting requested various improvements such as signalization or installation of an all-way stop, studies were conducted and these improvements were found not to be warranted. Curve warning signing was installed at the turn from Belvedere Road to Orlando Road and speed hump pavement markings were refreshed approaching the speed humps north of Colonial Drive.

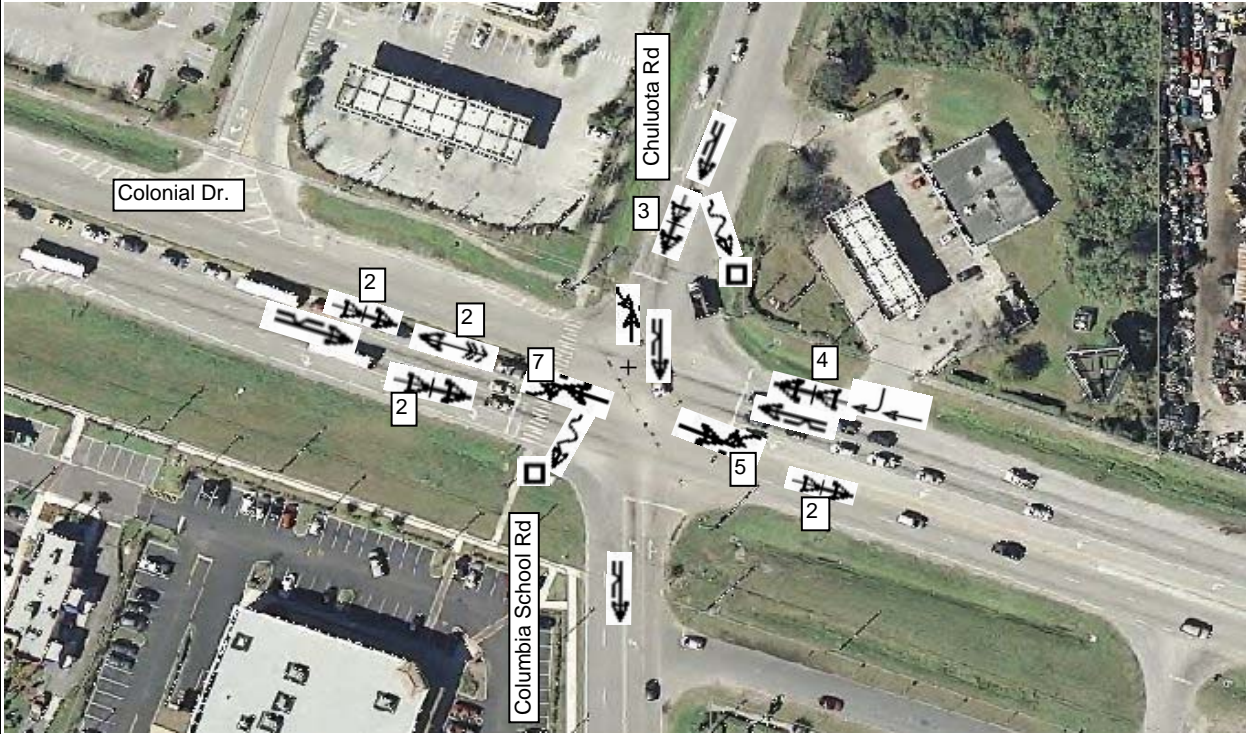
LOCATION ID: Chuluota Road and Colonial Drive

Crash Summary											
Location: CHULUOTA ROAD						Intersection Control: Signalized					
Intersecting Route: COLONIAL DRIVE						M.P.:		Engineer: CNL			
Study Period From: 2006						To: 2008		County: Orange			
NO.	DATE	DAY	TIME	TYPE	FATAL	INJURY	PROPERTY DAMAGE	DAY/NIGHT	WET/DRY	CONTRIBUTING CAUSE	ACCIDENT REPORT #
1	1/24/2006	Tues.	11:42 AM	out of control	No	Yes	\$24,000	Day	Wet	Careless Driving; Hydroplaned	FHPD06OFF008051
2	3/31/2006	Fri.	10:48 PM	rear-end	No	Yes	\$13,500	Night	Dry	Failure to Yield ROW; Careless Driving	FHPD06OFF034272
3	4/10/2006	Mon.	1:18 PM	left turn	No	Yes	\$10,000	Day	Dry	Careless Driving	FHPD06OFF038112
4	4/12/2006	Wed.	9:40 PM	rear-end	No	No	\$2,000	Night	Dry	Careless Driving	FHPD06OFF039040
5	8/14/2006	Mon.	8:40 PM	left turn	No	Yes	\$8,000	Night	Dry	Failure to Yield ROW	FHPD06OFF086984
6	10/13/2006	Fri.	8:20 AM	left turn	No	Yes	\$5,100	Day	Dry	Failure to Yield ROW	FHPD06OFF109357

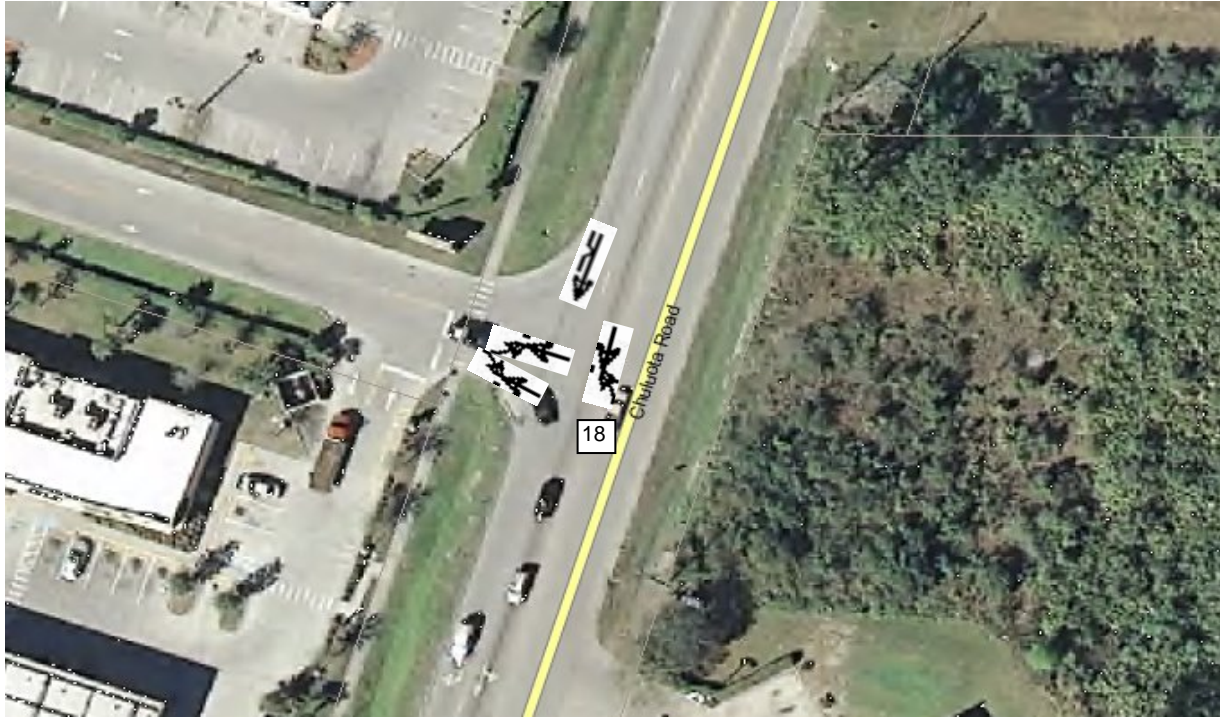
LOCATION ID: Chuluota Road and Publix driveway

Crash Summary											
Location: CHULUOTA ROAD						Intersection Control: Stop Controlled at driveway					
Intersecting Route: PUBLIX DRIVEWAY						M.P.:		Engineer: CNL			
Study Period From: 2006						To: 2008		County: Orange			
NO.	DATE	DAY	TIME	TYPE	FATAL	INJURY	PROPERTY DAMAGE	DAY/NIGHT	WET/DRY	CONTRIBUTING CAUSE	ACCIDENT REPORT #
1	2/17/2006	Fri.	7:56 AM	left turn	No	Yes	\$4,700	Day	Dry	Failed to Yield R/W; Improper Turn	FHPD06OFF017176
2	2/20/2006	Mon.	6:17 PM	left turn	No	Yes	\$8,000	Night	Dry	Failed to Yield R/W	FHPD06OFF018606
3	3/5/2006	Sun.	8:40 PM	left turn	No	No	\$2,000	Night	Dry	Careless Driving	FHPD06OFF023737
4	10/18/2006	Wed.	5:57 PM	left turn	No	Yes	\$10,000	Day	Dry	Failed to Yield R/W	FHPD06OFF111216
5	4/21/2007	Sat.	12:46 PM	left turn	No	No	\$6,000	Day	Dry	Failed to Yield R/W	FHPD07OFF041185
6	5/23/2007	Wed.	6:19 PM	left turn	No	No	\$6,000	Day	Dry	Failed to Yield R/W	FHPD07OFF052730
