TABLE 1
Estimated Groundwater Elevation
Sunbridge Parkway PDS - ROADWAY and PONDS
Orange County, Florida
PSI Project No. 07571768

TABLE 2 Summary of Cemented Sand and Very Dense Sand Locations SUNDBRIDGE PARKWAY PDS Orange County, Florida PSI Project No. 07571768

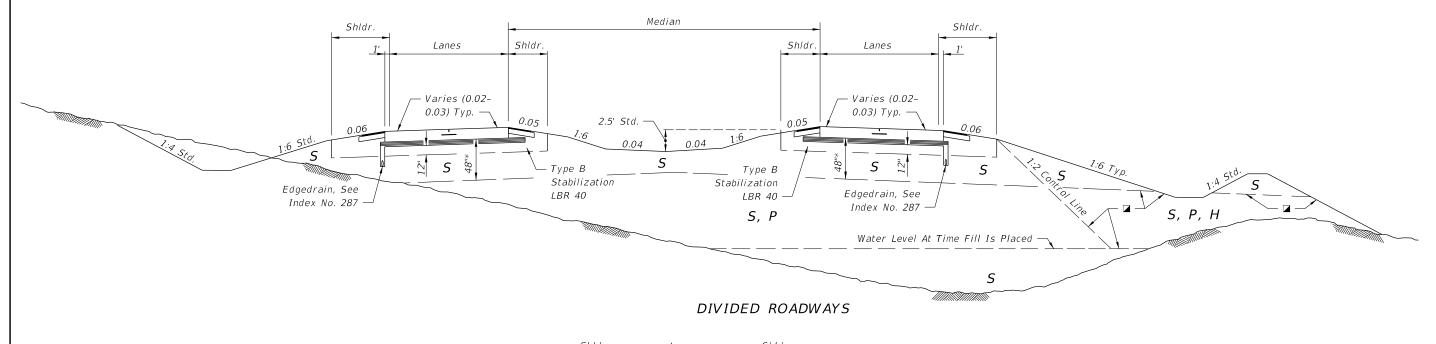
SHEET NO. 3 of 4

UNDIVIDED ROADWAY

placed on a working platform using 12" of Type B Stabilization.

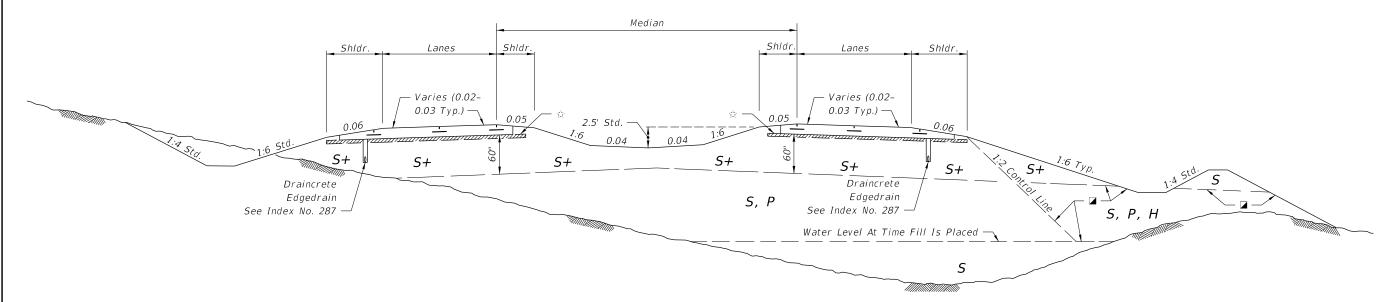
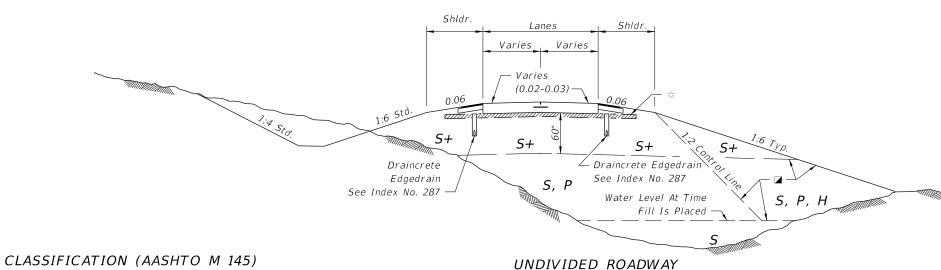
DIVIDED ROADWAYS

<u>SYMBOL</u>	<u> </u>	CLASSIFICATION (AASHTO M 145)	UN
5	Select	A-1, A-3, A-2-4 **	
S+	Special Select	A-3 *** With Minimum Average Lab Permeability of 5x10 ⁻⁵ cm/sec. (0.14 ft./day) as per AASHTC) T 215

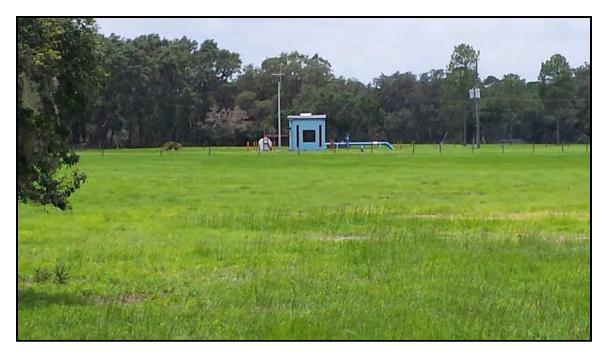
Photo 31: View of the City of Cocoa water supply well and associated AST located approximately 170-feet west of the central portion of the study corridor on the south side of TM Ranch Road.

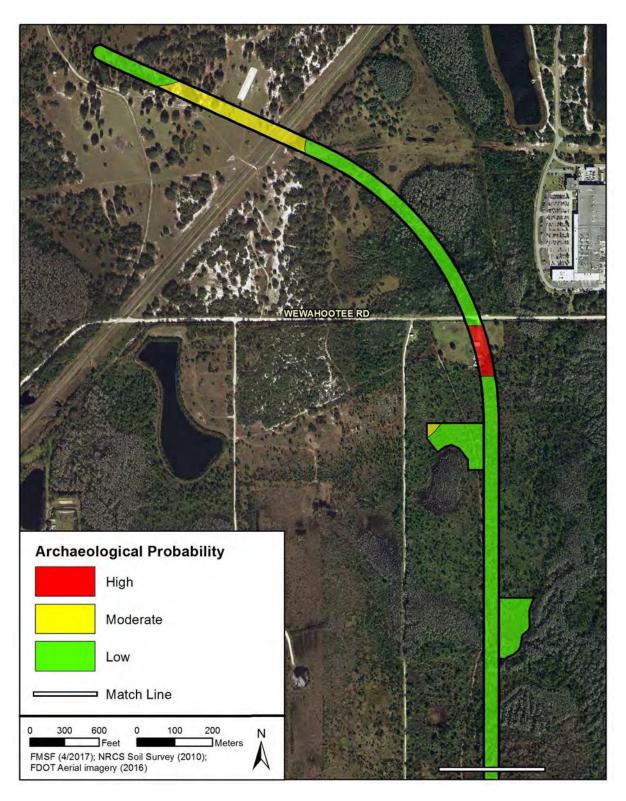
Figure 5. Archaeological probability within the northern portion of the Sunbridge Parkway right-of-way and Pond footprints.

Archaeological site probability was based on soil drainage and the distance to previously recorded archaeological sites and structures, as well as distance to unrecorded historic buildings and structures. **Figures 5**, **6**, **7** and **8** depict the distribution of high, medium, and low archaeological probability areas within the road right-of-way and pond footprints where ground-disturbing activities are proposed. Approximately 71 percent of the project area is low probability, 24.5 percent moderate, and 4.5 percent high.

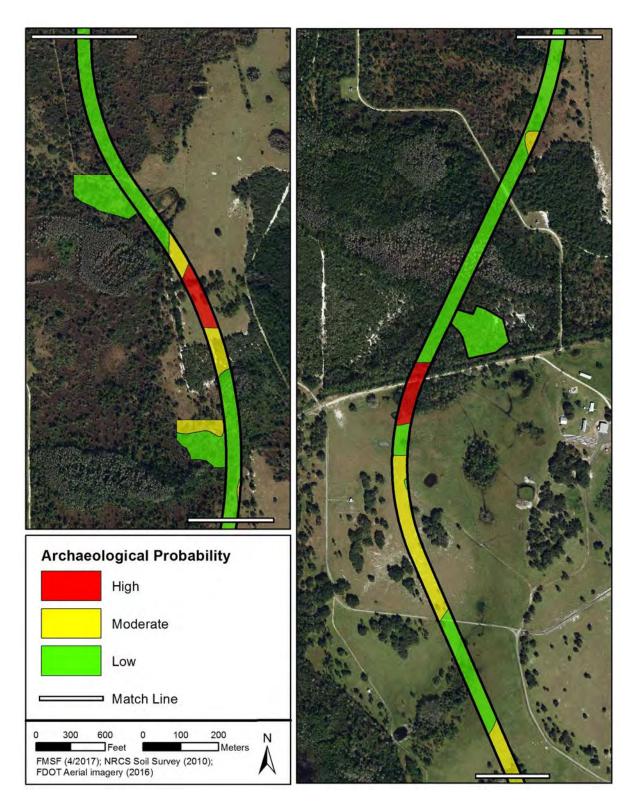
Figure 6. Archaeological probability within the northern-central portion of the Sunbridge Parkway right-of-way and Pond footprints.

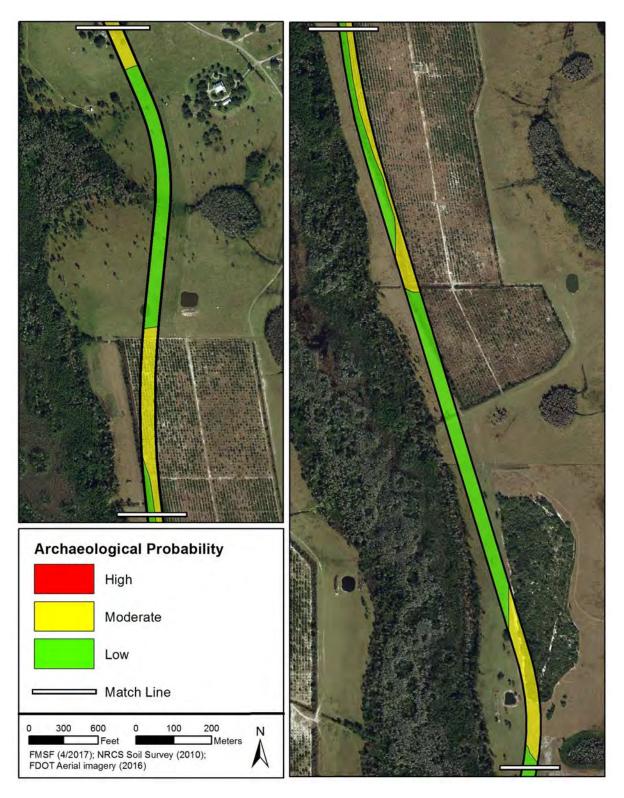
Figure 7. Archaeological probability within the southern-central portion of the Sunbridge Parkway right-of-way and Pond footprints.

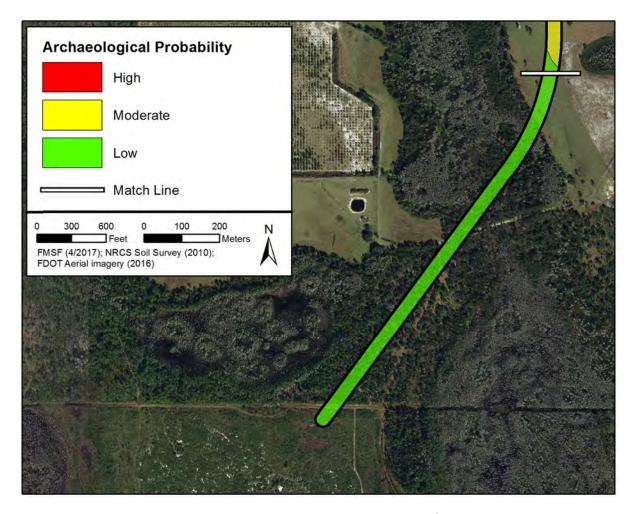
Figure 8. Archaeological probability within the southern portion of the Sunbridge Parkway right-of-way and Pond footprints.
