Subject: Lake Butler Buoy Permitting and Installation Memorandum
Orange County, Florida
Orange County Contract Number Y20-906B

**ORANGE COUNTY, LAKE BUTLER BUOY PERMITTING & INSTALLATION
(SUBCONTRACT WORK ORDER 100039555, PROJECT# FW9108)**

SUBJECT: Lake Butler Buoy Post-Installation Summary Memo

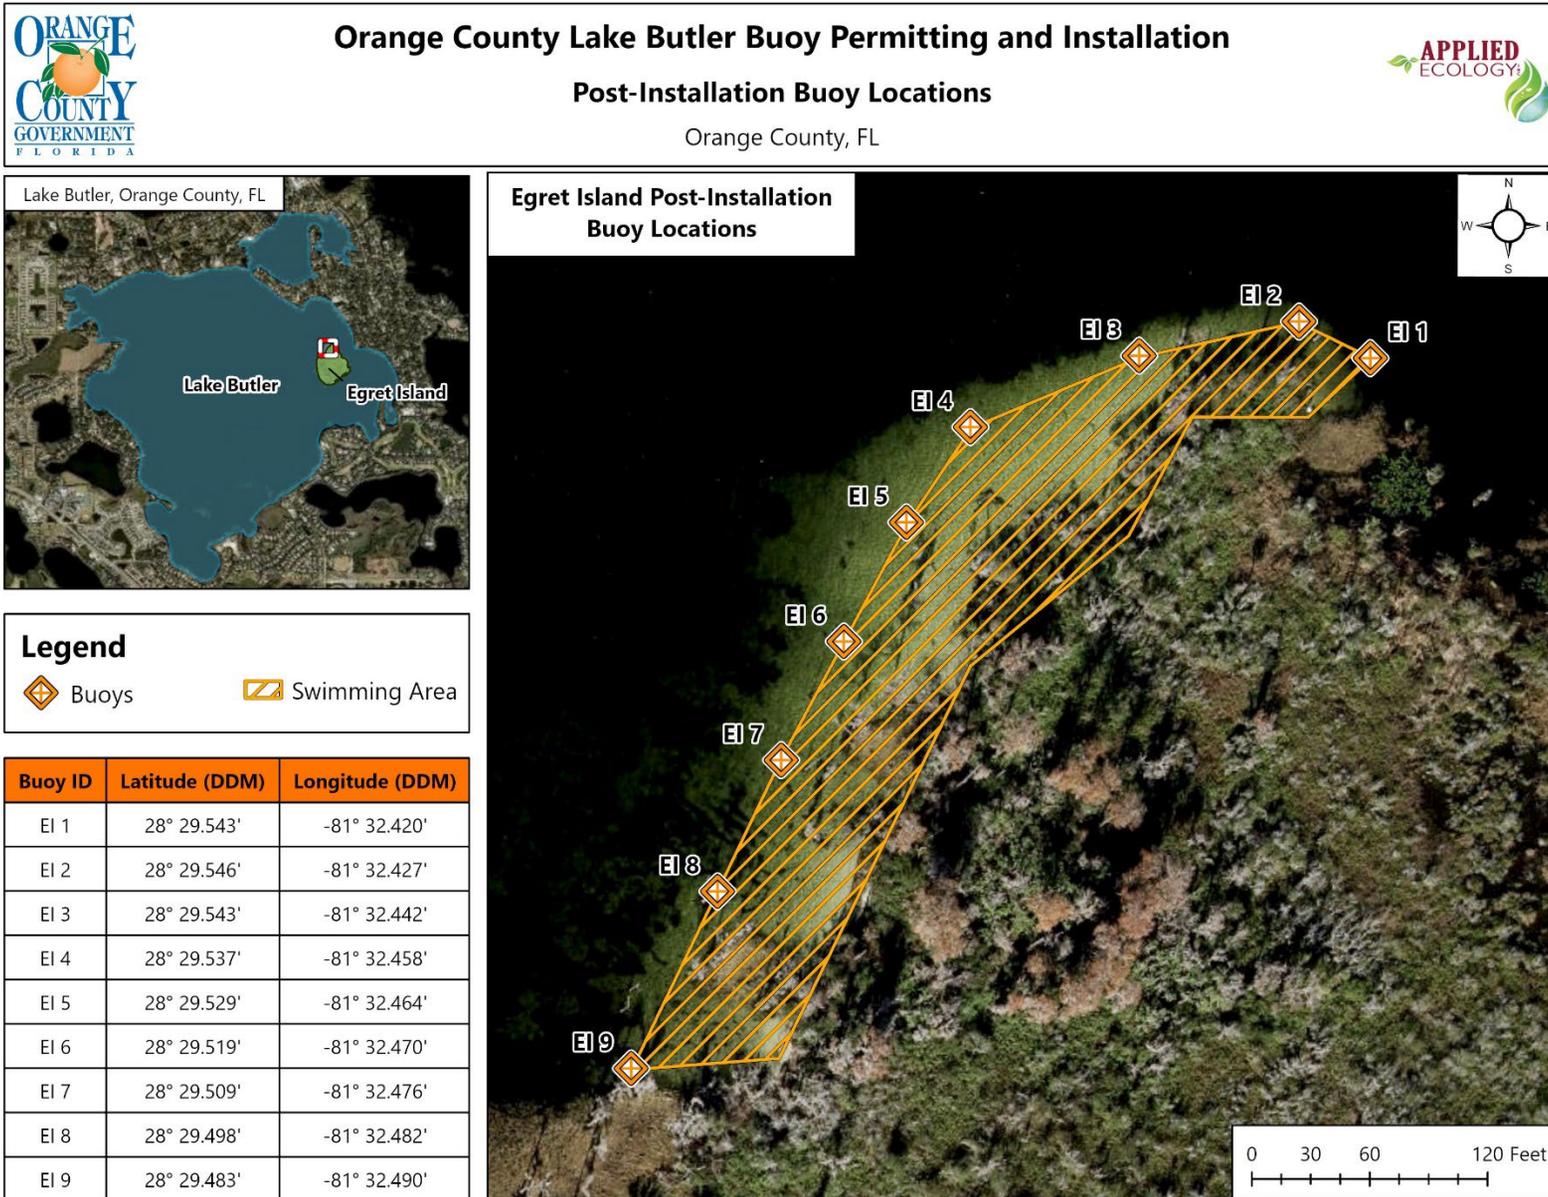
Figure 1. Post-installation buoy locations on Lake Butler's Egret Island.

Upon arrival at each location, AEI staff utilized a Trimble R2 GNSS GPS with a submeter accuracy to navigate to the installation locations for buoy installation as identified within Orange County’s Ordinance (Ord. No. 2022-20). AEI staff once again collected GPS coordinates for the exact installation location (Table 2); the accuracy of the GPS did not deviate more than 6 inches during the installation activities. Figure 1 presents the post-installation buoy locations buoys along the northwestern shore of Egret Island.

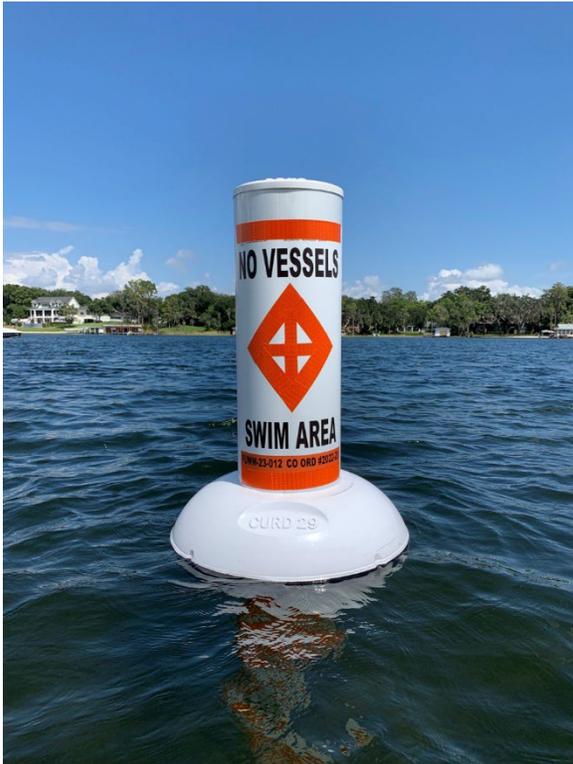
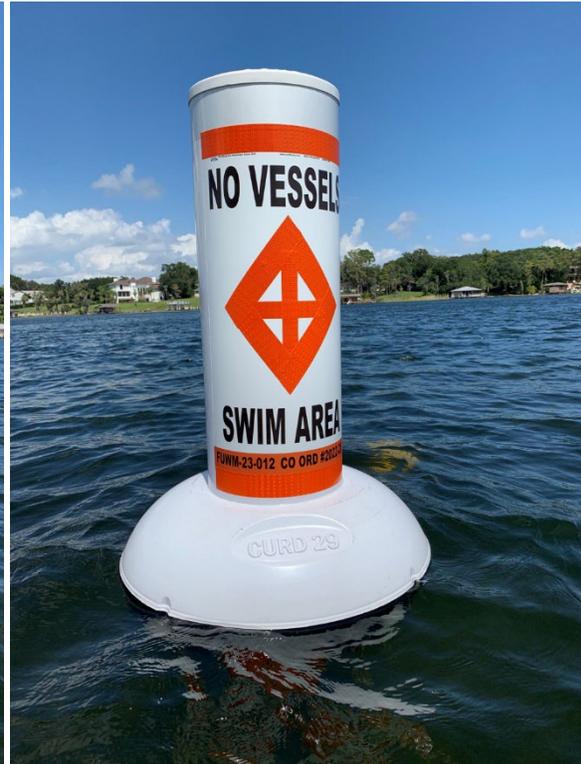
EI 1

Post installation photos of all nine buoys with retro-reflective tape were collected and are included below.
