**NORTHWEST ORANGE COUNTY  
TRAFFIC SAFETY AUDIT  
ORANGE COUNTY DISTRICT 2**

**PUBLIC WORKS DEPARTMENT  
TRAFFIC ENGINEERING DIVISION**

FEBRUARY 2010

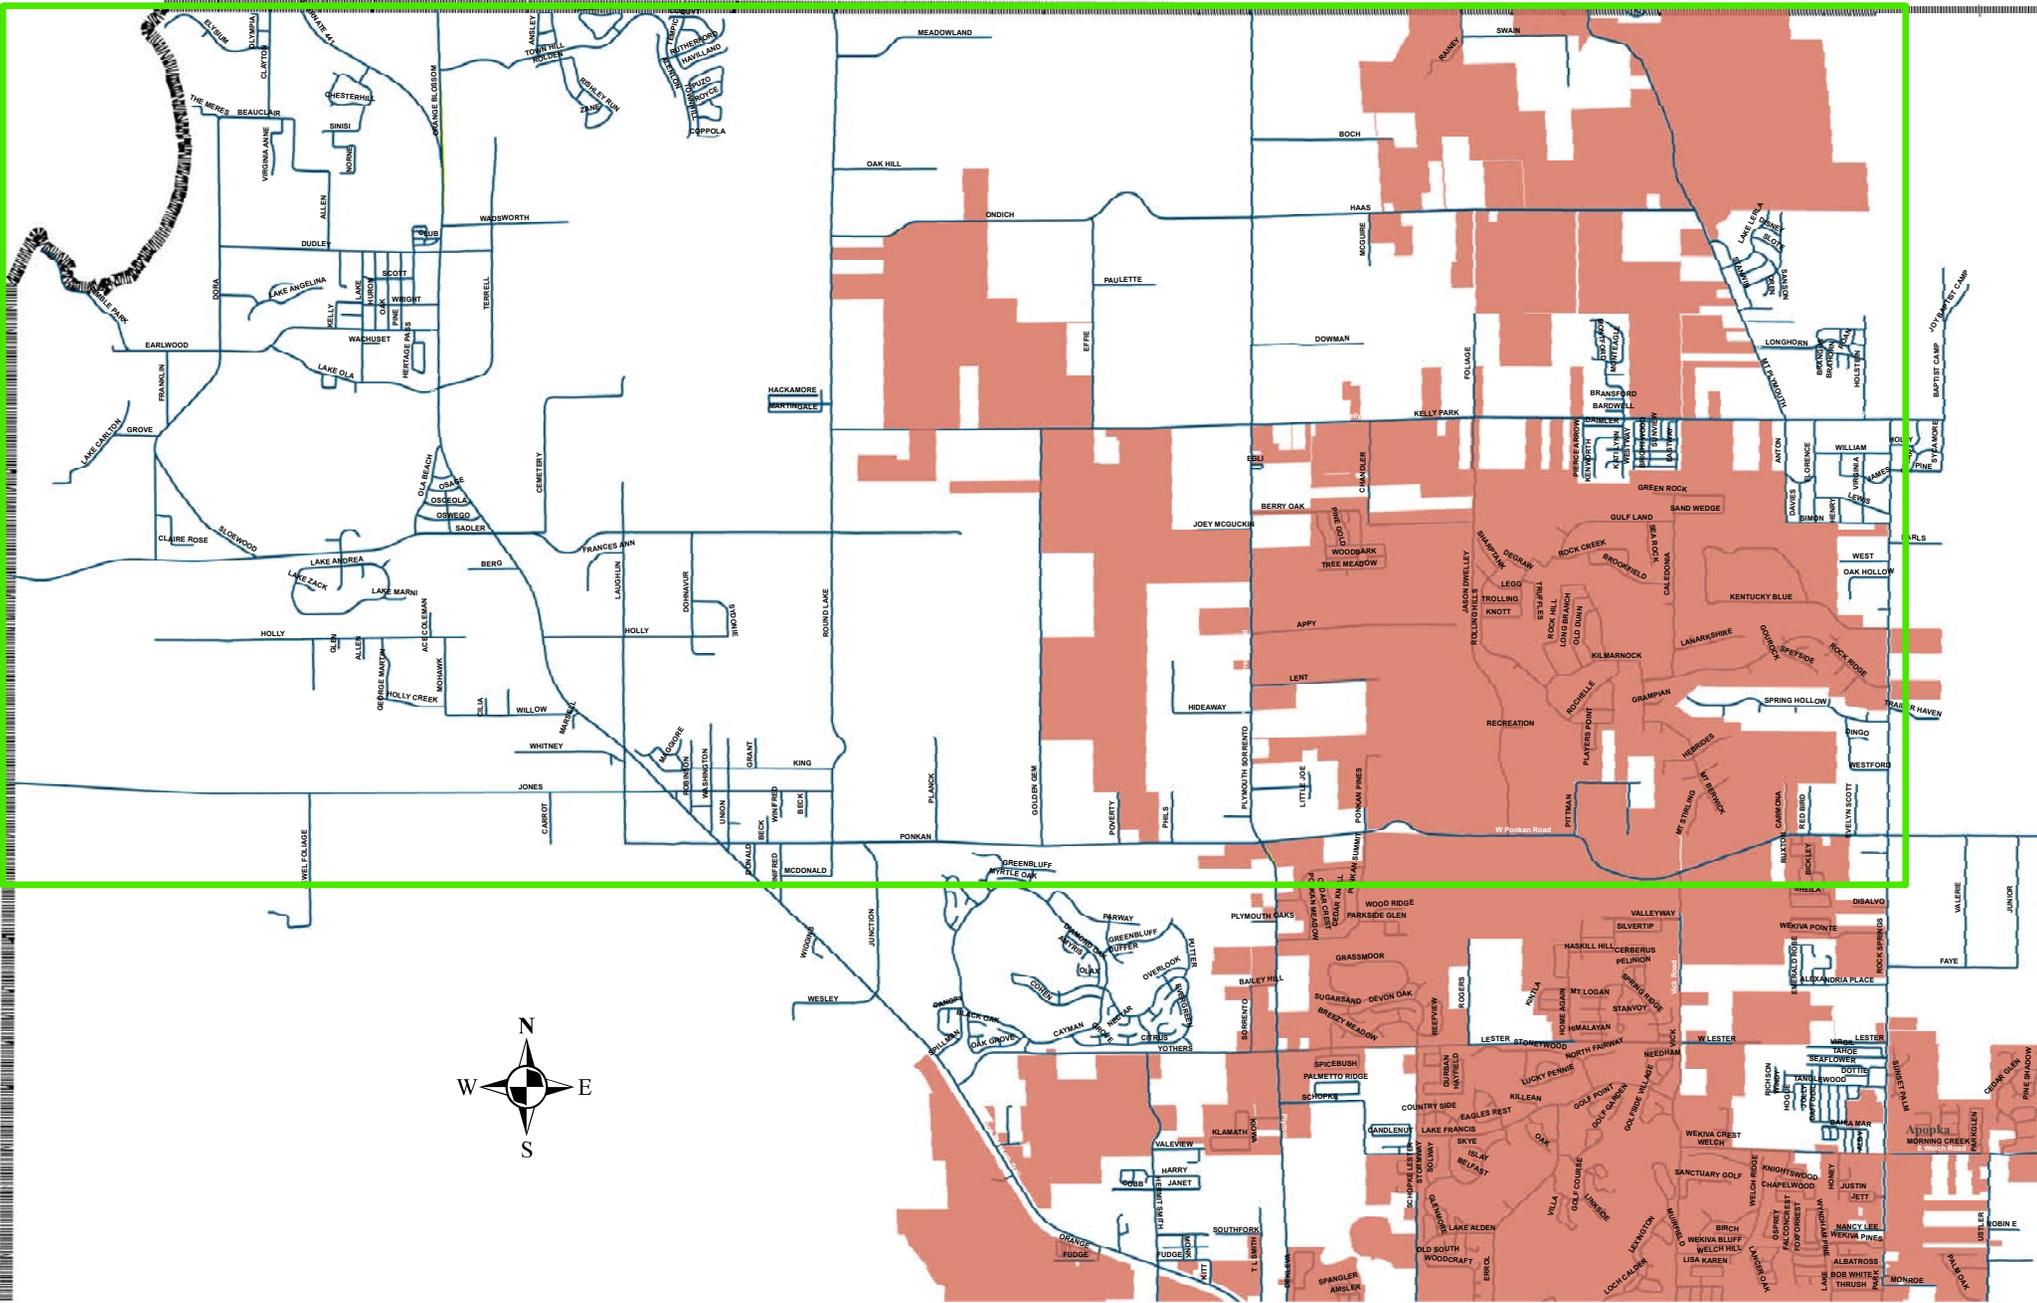
The study area boundaries are Ponkan Road on the south, Rock Springs Road on the east, and the Lake County line on both the west and the north. The location of the study area is presented in Figure 1.

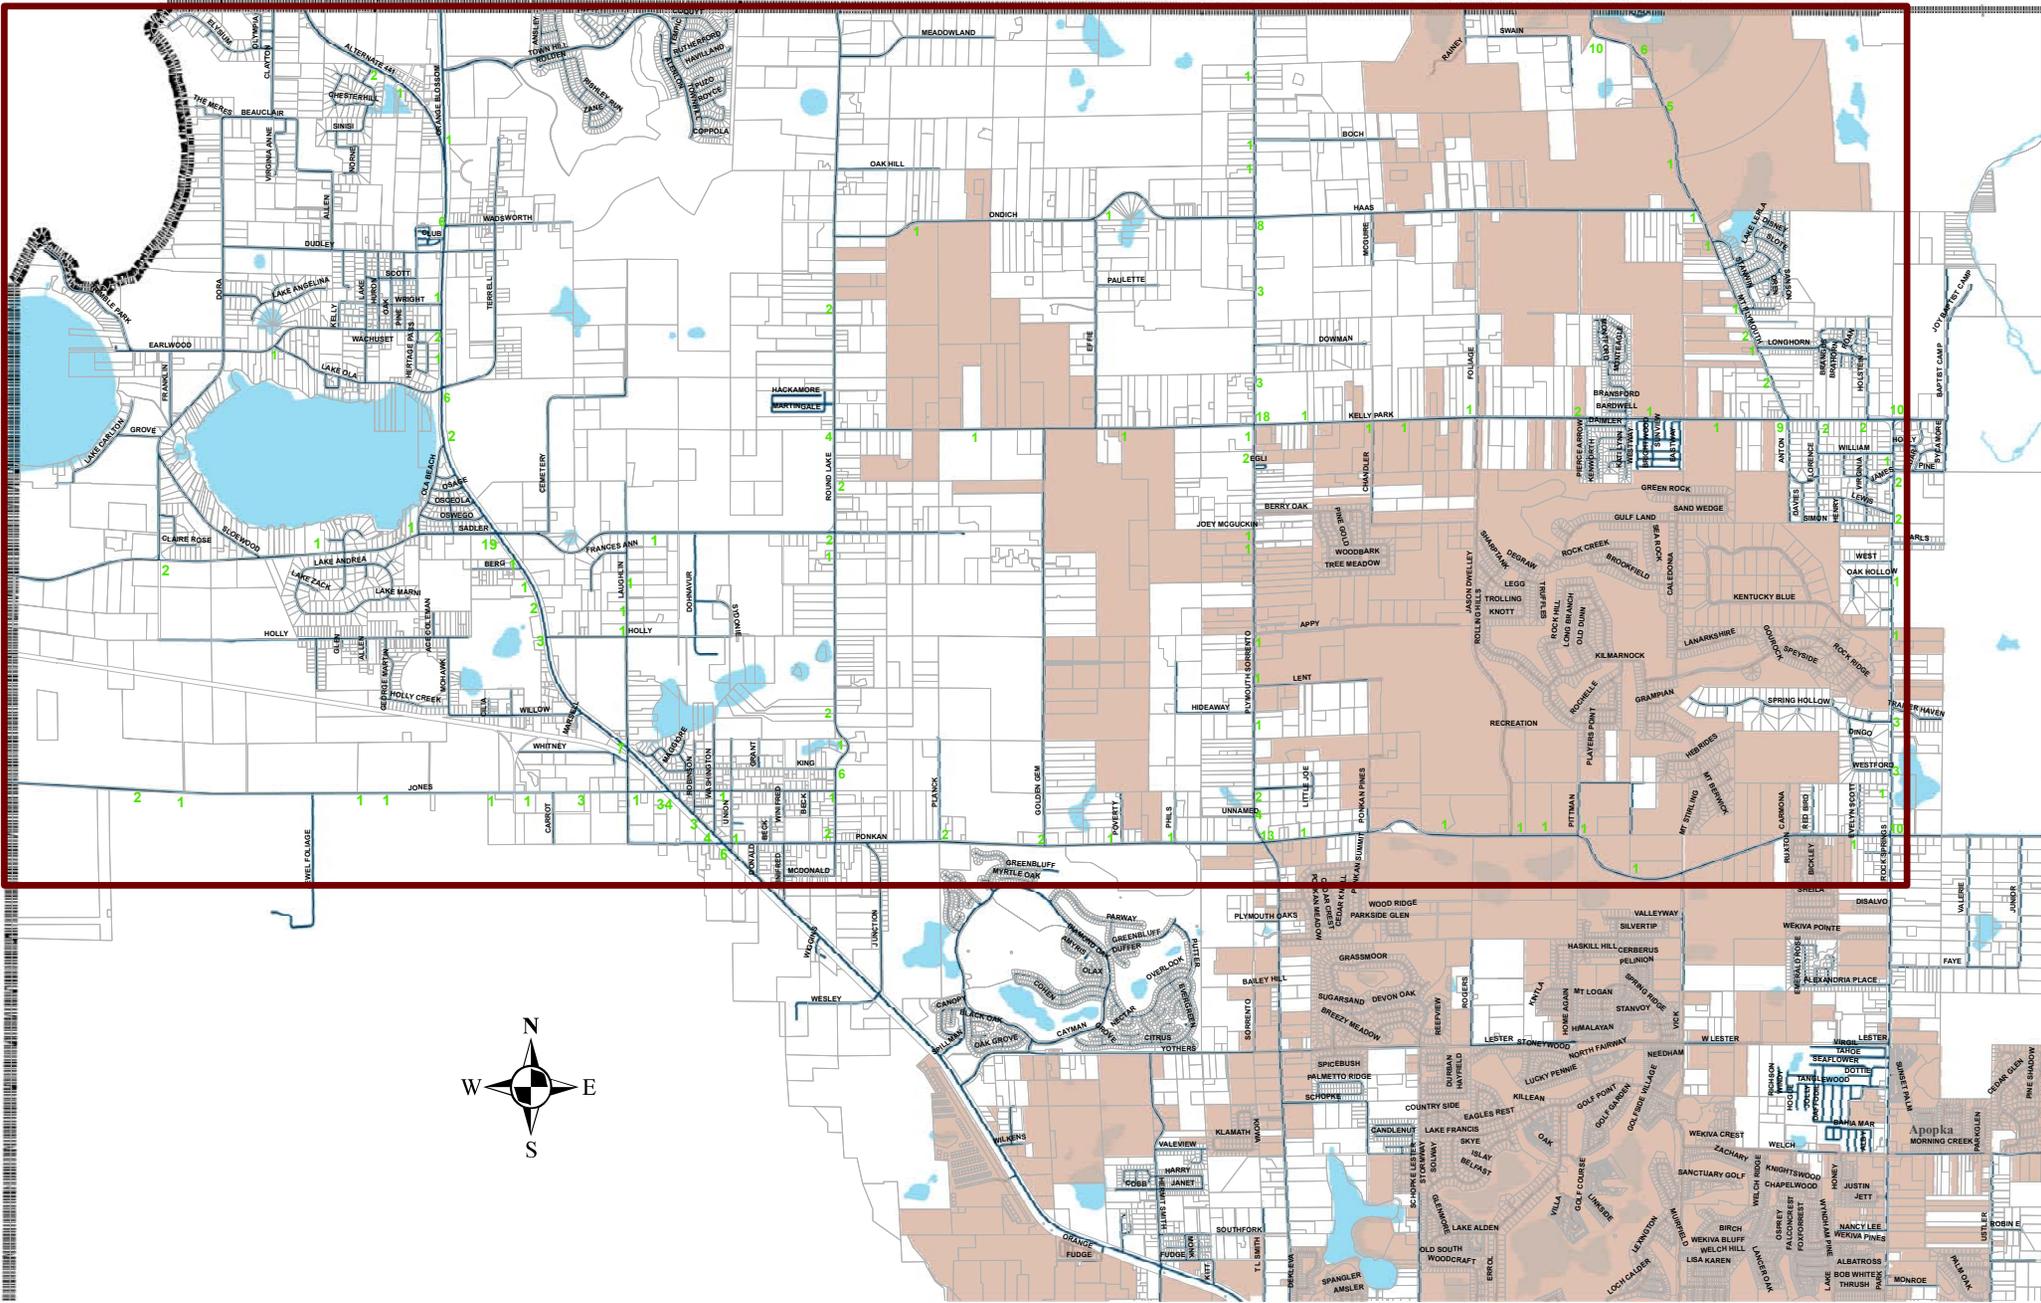
Figure 2

Northwest Orange County Traffic Safety Audit  
 Crash History 2006-2008

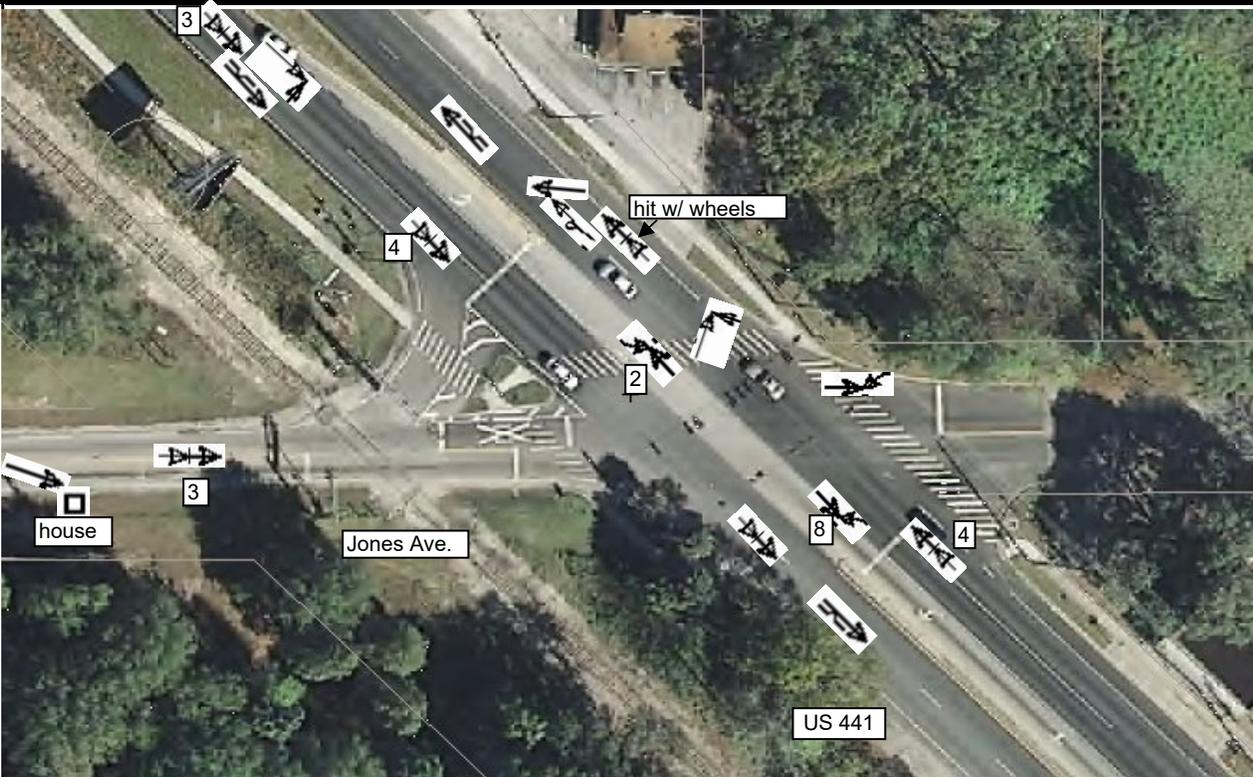
Crash Summary											
Location: JONES AVENUE						Intersection Control: Signalized					
Intersecting Route: US 441						M.P.:		Engineer: CNL			
Study Period From: 2006						To: 2008		County: Orange			
NO.	DATE	DAY	TIME	TYPE	FATAL	INJURY	PROPERTY DAMAGE	DAY/NIGHT	WET/DRY	CONTRIBUTING CAUSE	ACCIDENT REPORT #
1	1/21/2006	Sat	11:28 AM	Right angle	No	No	\$5,000	Day	Dry	Careless driving	FHPD06OFF007046
2	2/6/2006	Mon	1:35 PM	Left Turn	No	No	\$3,000	Day	Dry	Failed to Yield R/W	FHPD06OFF013065
3	4/1/2006	Sat	3:10 PM	Left Turn	No	No	\$11,000	Day	Dry	Failed to Yield R/W	FHPD06OFF034547
4	4/10/2006	Mon	8:18 AM	Left Turn	No	Yes	\$10,000	Day	Dry	Failed to Yield R/W; improper passing	FHPD06OFF038009
5	5/31/2006	Wed	11:59 AM	Left Turn	No	No	\$3,500	Day	Dry	Red light running	FHPD06OFF057737
6	8/28/2006	Mon	6:45 AM	Rear end	No	No	\$10,300	Day	Dry	Careless driving	FHPD06OFF092184
7	9/7/2006	Wed	12:48 PM	Rear end	No	Yes	\$2,050	Day	Dry	Careless driving	FHPD06OFF096183

8	9/26/2006	Tue	6:07 PM	Rear end	No	No	\$6,000	Day	Wet	Careless driving	FHPD06OFF103492
9	10/3/2006	Tue	8:05 AM	Rear end	No	No	\$600	Day	Dry	Careless driving	FHPD06OFF105845
10	11/2/2006	Thu	3:56 PM	Right Turn	No	No	\$10,000	Day	Dry	Failed to Yield R/W	FHPD06OFF116737
11	12/2/2006	Sat	10:16 AM	Rear end	No	Yes	\$12,500	Day	Dry	Careless driving	FHPD06OFF127784
12	2/16/2007	Fri	2:29 PM	Sideswipe	No	Yes	\$7,000	Day	Dry	Improper Lane Change; Failure to Yield R/W	FHPD07OFF016287
13	2/19/2007	Mon	8:21 AM	Rear end	No	No	\$125	Day	Dry	Careless driving	FHPD07OFF017256
14	2/20/2007	Tue	4:29 PM	Rear end	No	No	\$10,000	Day	Dry	Careless driving	FHPD07OFF017742
15	3/24/2007	Sat	4:25 AM	Run off road	No	No	\$3,500	Night	Dry	Unknown, hit house	FHPD07OFF030234
16	5/14/2007	Mon	9:42 AM	Sideswipe	No	No	\$10,000	Day	Wet	Improper Lane Change	FHPD07OFF049364
17	6/11/2007	Mon	1:51 PM	Sideswipe	No	No	\$2,200	Day	Dry	Improper Lane Change	FHPD07OFF059465

18	8/2/2007	Thu	6:51 PM	Right Angle	No	No	\$8,500	Day	Wet	Improper Turn	FHPD07OFF079061
19	8/8/2007	Wed	6:11 AM	Rear end	No	Yes	\$6,500	Night	Dry	Failed to Yield R/W; Careless	FHPD07OFF081088
20	8/23/2007	Thu	10:03 AM	Rear end	No	Yes	\$500	Day	Dry	Careless driving	FHPD07OFF086897
21	9/2/2007	Sun	8:58 PM	Rear end	No	No	\$2,000	Night	Dry	Careless driving	FHPD07OFF091095
22	10/18/2007	Thu	4:16 PM	Left Turn	No	No	\$7,000	Day	Dry	Failed to Yield R/W	FHPD07OFF107749

23	10/24/2007	Wed	6:39 AM	Rear end	No	Yes	\$6,000	Day	Dry	Careless driving	FHPD07OFF109983
24	11/5/2007	Mon	8:42 AM	Left Turn	No	No	\$1,500	Day	Dry	Failed to Yield R/W	FHPD07OFF114718
25	11/6/2007	Tue	3:16 PM	Other	No	No	\$3,000	Day	Dry	Tires came off axle and struck other car	FHPD07OFF115171
26	11/7/2007	Wed	10:31 PM	Rear end	No	No	\$1,000	Night	Dry	Careless driving	FHPD07OFF115604
27	11/11/2007	Sun	6:36 PM	Left Turn	No	Yes	\$3,000	Night	Dry	Failed to Yield R/W	FHPD07OFF116907
28	2/21/2008	Thu	9:00 AM	Rear end	No	Yes	\$2,500	Day	Wet	Careless driving	FHPD08OFF017267
29	2/22/2008	Fri	6:54 AM	Left Turn	No	Yes	\$16,000	Day	Dry	Failed to Yield R/W	FHPD08OFF017651
30	3/14/2008	Fri	2:09 PM	Left Turn	No	Yes	\$17,500	Day	Dry	Red Light Running	FHPD08OFF025324
31	7/25/2008	Fri	4:28 PM	Left Turn	No	Yes	\$17,000	Day	Dry	Both stated they had the green	FHPD08OFF071340
32	7/27/2008	Sun	10:25 AM	Rear end	No	Yes	\$3,000	Day	Dry	DUI, careless driving	FHPD08OFF071882

33	10/23/2008	Thu	7:51 PM	Rear end	No	No	\$1,200	Night	Dry	Careless driving	FHPD08OFF099026
34	12/13/2008	Sat	7:02 AM	Left Turn	No	No	\$5,000	Day	Dry	Both stated they had the green	FHPD08OFF114627
TOTAL											
TOTAL NO.	FATAL	INJURY	PROPERTY DAMAGE	ANGLE	LEFT TURN	RIGHT TURN	REAR END	SIDE SWIPE	HEAD ON		
34	0	13	34	2	11	1	15	3	0		
%	0%	38%	100%	6%	32%	3%	44%	9%	0%		
ONE VEHICLE	PED/BIKE	DAY	NIGHT	WET	DRY	EXCESS SPEED	FTY R/W	DUI			
0	0	28	6	4	30	0	10	1			
0%	0%	82%	18%	12%	88%	0%	29%	3%			
TOTAL VEHICLES ENTERING/ADT:					CRASH RATE:				MEV

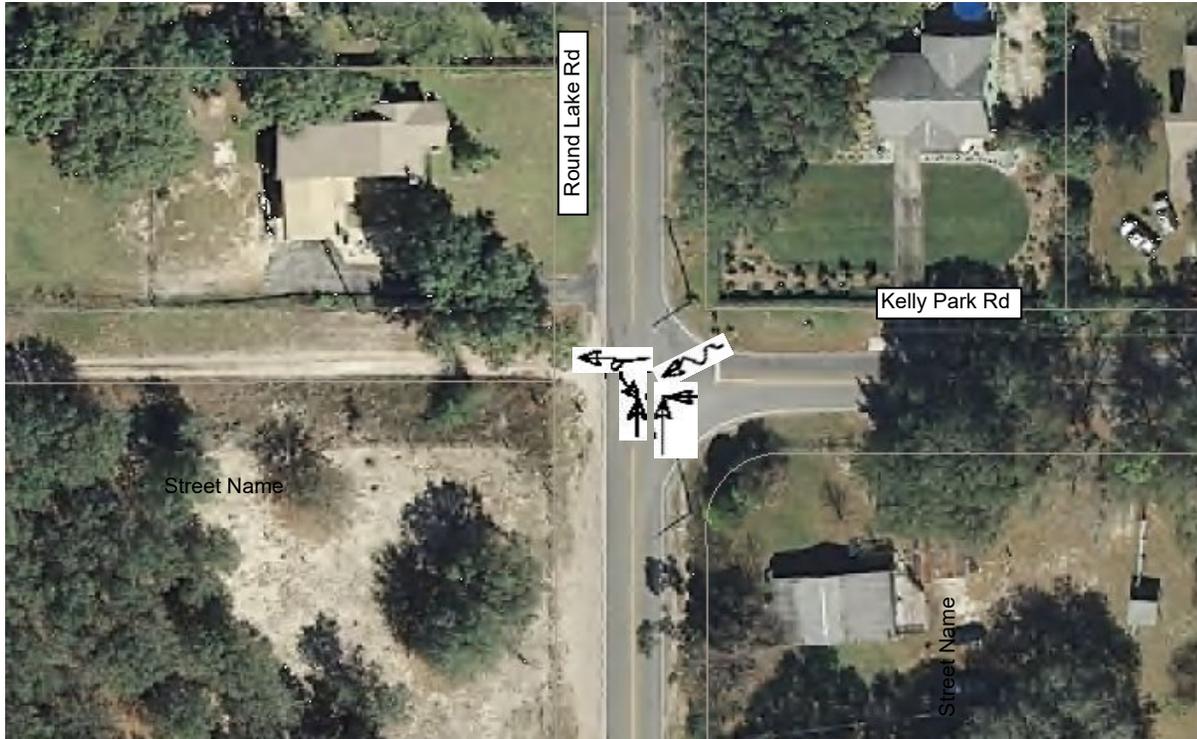
LOCATION ID: Kelly Park Rd and Round Lake Rd

At the intersection of Kelly Park Road with Round Lake Road three of the four crashes appear to be caused by drivers not stopping at the stop sign.

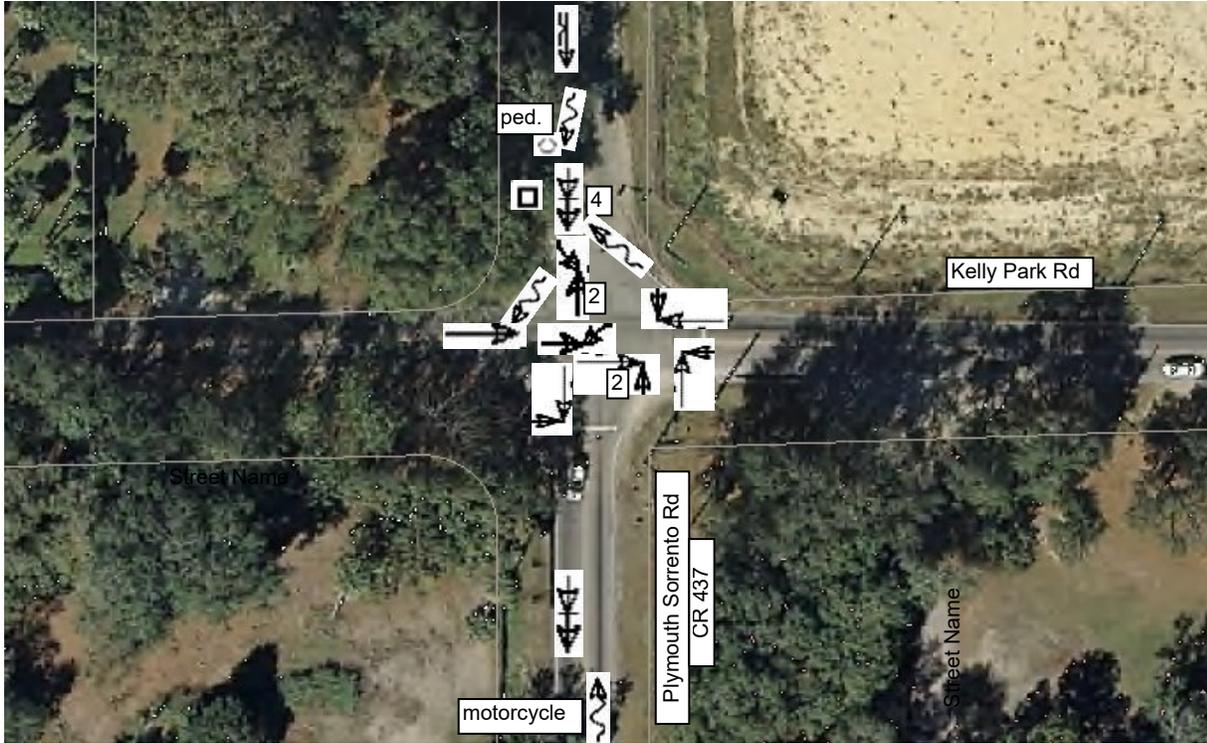
LOCATION ID: Kelly Park Rd and Plymouth Sorrento Rd

At the intersection of Kelly Park Road with Plymouth Sorrento Road 22 percent of the crashes are right angle crashes caused by red light running. Twenty-eight percent of the crashes are rear-end crashes.

Crash Summary											
Location: KELLY PARK ROAD						Intersection Control: Signalized					
Intersecting Route: PLYMOUTH SORRENTO ROAD						M.P.:		Engineer: CNL			
Study Period From: 2006				To: 2008				County: Orange			
NO.	DATE	DAY	TIME	TYPE	FATAL	INJURY	PROPERTY DAMAGE	DAY/NIGHT	WET/DRY	CONTRIBUTING CAUSE	ACCIDENT REPORT #
1	5/20/2006	Sat	8:49 PM	Rear End	No	No	\$5,000	Night	Dry	Careless Driving	FHPD06OFF053832
2	7/21/2006	Fri	3:56 PM	Rear end	No	No	\$3,600	Day	Wet	Careless Driving	FHPD06OFF077699
3	9/7/2006	Thu	5:20 PM	Rear end	No	Yes	\$3,000	Day	Wet	Careless Driving	FHPD06OFF096329
4	11/04/2006	Sat	9:53AM	Left turn	No	No	\$1,000	Day	Dry	Failure to Yield R/W	FHPD06OFF117348
5	11/29/2006	Wed	8:30AM	Out Of Control	No	Yes	\$7,000	Day	Wet	Careless driving/brakes locked	FHP06OFF126466
6	12/28/2006	Thu	6:43 AM	Right Angle	No	Yes	\$19,000	Day	Dry	Red Light Running	FHPD06OFF137169
7	3/31/2007	Sat	1:05 AM	Left turn	No	No	\$5,000	Night	Dry	Failure to Yield R/W	FHPD07OFF033034

8	7/15/2007	Sun	5:02 PM	Right Angle	No	Yes	\$20,000	Day	Dry	Red Light Running	FHPD07OFF071968
9	8/31/2007	Fri	8:17 PM	Right Angle	No	No	\$8,000	Day	Dry	Red Light Running	FHPD07OFF090339
10	9/28/2007	Fri	8:33PM	Rear end	No	Yes	\$6,000	Night	Dry	Careless Driving	FHPD07OFF100567
11	12/12/2007	Wed	7:57 AM	Right Turn	No	No	\$2,000	Day	Dry	Failure to Yield R/W	FHPD07OFF127364
12	12/30/2007	Sun	7:42 AM	Out Of Control	No	No	\$200	Day	Wet	Unknown/single motorcycle	FHPD07OFF133901
13	5/5/2008	Mon	5:22 PM	Left turn	No	Yes	\$10,000	Day	Dry	Failure to Yield R/W	FHPD08OFF044185
14	8/3/2008	Sun	2:05 AM	Out Of Control	No	Yes	\$0	Night	Dry	Careless/hit pedestrian	FHPD08OFF073954
15	8/23/2008	Sat	6:30 PM	Rear end	No	No	\$250	Day	Wet	Careless Driving	FHPD08OFF080648
16	8/27/2008	Wed	11:17 PM	Out Of Control	No	Yes	\$5,000	Night	Dry	Careless Driving	FHPD08OFF81981
17	10/24/2008	Fri	7:02 AM	Right Angle	No	Yes	\$12,500	Day	Wet	Red Light Running	FHPD08OFF099160

18	12/21/2008	Sun	12:23 PM	Side swipe	No	No	\$8,000	Day	Dry	Passing on shoulder	FHPD08OFF117106
TOTAL											
TOTAL NO.	FATAL	INJURY	PROPERTY DAMAGE	ANGLE	LEFT TURN	RIGHT TURN	REAR END	SIDE SWIPE	HEAD ON		
18	0	9	17	4	3	1	5	1	0		
%	0%	50%	94%	22%	17%	6%	28%	6%	0%		
ONE VEHICLE	PED/BIKE	DAY	NIGHT	WET	DRY	EXCESS SPEED	FTY R/W	DUI			
3	1	13	5	6	12	0	3	0			
	17%	6%	72%	28%	33%	67%	0%	17%			
TOTAL VEHICLES ENTERING/ADT:						CRASH RATE:			MEV

Speed studies were conducted for all approaches to the Kelly Park Road/Plymouth Sorrento Road intersection to evaluate and adjust clearance timings in an effort to reduce high-priority right angle red light running crashes and rear-end crashes at this intersection. It was evident by field observation, and confirmed by citizens, that vehicles are leaving the pavement edge to maneuver around left turning vehicles waiting to turn. As the pavement edge deteriorates, it becomes a safety hazard that requires ongoing maintenance. As funds become available for intersection improvement projects it is recommended that turn lanes be added on all approaches.

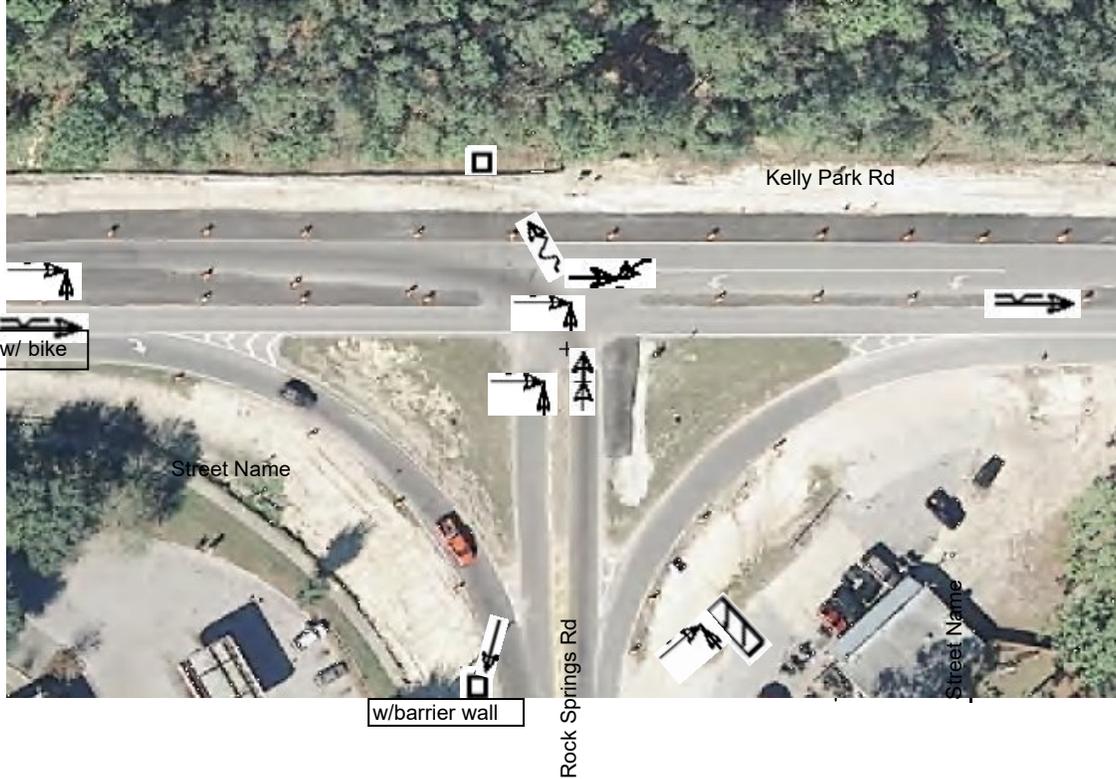
The intersection of Kelly Park Road with Rock Springs Road has been recently reconfigured. The previous intersection configuration was stop control on Rock Springs Road, but now the intersection is signalized with the main movement occurring between Kelly Park Road west of Rock Springs Road and Rock Springs Road. The crash analyses shown for this intersection is related to pre-construction conditions.

Crash Summary											
Location: ROCK SPRINGS ROAD						Intersection Control: Stop sign on Rock Springs Rd					
Intersecting Route: KELLY PARK ROAD						M.P.:		Engineer: CNL			
Study Period From: 2006						To: 2008		County: Orange			
NO.	DATE	DAY	TIME	TYPE	FATAL	INJURY	PROPERTY DAMAGE	DAY/NIGHT	WET/DRY	CONTRIBUTING CAUSE	ACCIDENT REPORT #
1	6/22/2006	Thu	6:18 AM	Side Swipe	No	No	\$250	Night	Dry	Careless driving, Bike sharing roadway; foggy	FHPD06OFF066021
2	7/15/2006	Sat	4:03 PM	Right Angle	No	Yes	\$7,000	Day	Dry	Careless driving, improper U-turn	FHPD06OFF075495
3	1/20/2007	Sat	9:24 PM	Out Of Control	No	No	\$3,100	Night	Dry	Unknown	FHPD07OFF006824
4	3/16/2007	Fri	10:18 PM	Right Angle	No	No	\$6,000	Night	Dry	DUI	FHPD07OFF027555
5	7/4/2007	Sat	12:33 AM	Rear End	No	Yes	\$3,000	Night	Dry	Careless driving	FHPD07OFF067510
6	9/10/2007	Mon	1:37 AM	Out Of Control	No	No	\$500	Night	Dry	Did not stop at stop sign; run off road	FHPD07OFF093504

7	9/21/2007	Fri	11:48 AM	Left Turn	No	Yes	\$11,000	Day	Dry	Failure to Yield R/W	FHPD07OFF097752
8	11/3/2007	Sat	10:56 AM	Side Swipe	No	No	\$2,000	Day	Dry	Obstructing traffic; improper passing	FHPD07OFF114126
9	6/25/2008	Tue	8:46 AM	Left Turn	No	Yes	\$3,500	Day	Dry	Did not stop at stop sign; failure to yield R/W	FHPD08OFF061441
10	7/18/2008	Thu	6:46 PM	Out Of Control	No	Yes	\$1,000	Day	Dry	Careless driving; run off road	FHPD08OFF069152
TOTAL											
TOTAL NO.	FATAL	INJURY	PROPERTY DAMAGE	ANGLE	LEFT TURN	RIGHT TURN	REAR END	SIDE SWIPE	HEAD ON		
10	0	5	10	2	2	0	1	2	0		
%	0%	50%	100%	20%	20%	0%	10%	20%	0%		
ONE VEHICLE	PED/BIKE	DAY	NIGHT	WET	DRY	EXCESS SPEED	FTY R/W	DUI			
2	1	5	5	0	10	0	2	1			
20%	10%	50%	50%	0%	100%	0%	20%	10%			
TOTAL VEHICLES ENTERING/ADT:						CRASH RATE:			MEV

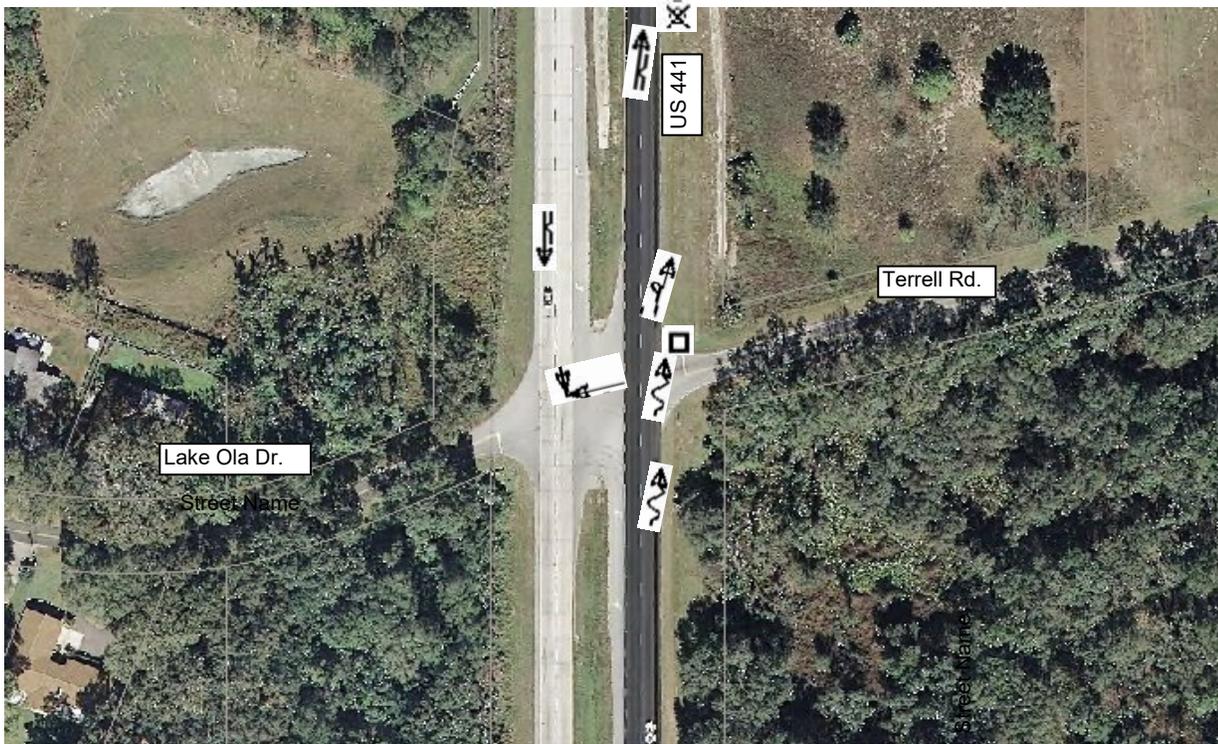
LOCATION ID: US 441 and Lake Ola Drive

Crash Summary											
Location: US 441						Intersection Control: stop control on Lake Ola/Terrell					
Intersecting Route: Lake Ola Drive/Terrell Road						M.P.:		Engineer: CNL			
Study Period From: 2006						To: 2008		County: Orange			
NO.	DATE	DAY	TIME	TYPE	FATAL	INJURY	PROPERTY DAMAGE	DAY/NIGHT	WET/DRY	CONTRIBUTING CAUSE	ACCIDENT REPORT #
1	1/11/2006	Wed	10:25 AM	sideswipe	No	No	\$7,000	Day	Dry	Improper Lane Change	FHPD06OFF003432
2	4/14/2006	Fri	11:00 AM	out of control	No	Yes	\$6,000	Day	Dry	Vehicle cut in front of	FHPD06OFF039536
3	9/7/2006	Thu	3:11 PM	out of control	No	No	\$5,000	Day	Wet	Careless Driving	FHPD06OFF096252
4	10/18/2006	Wed	3:11 PM	sideswipe	Yes	Yes	\$22,500	Day	Dry	Improper Lane Change	FHPD06OFF111148
5	10/22/2006	Sun	3:57 PM	right angle	No	Yes	\$10,000	Day	Dry	Failure to Yield R/W	FHPD06OFF112715
6	10/22/2007	Mon	7:31 AM	out of control	No	No	\$2,000	Day	Wet	Careless Driving	FHPD07OFF109277

TOTAL											
TOTAL NO.	FATAL	INJURY	PROPERTY DAMAGE	ANGLE	LEFT TURN	RIGHT TURN	REAR END	SIDE SWIPE	HEAD ON		
6	1	3	6	1	0	0	0	2	0		
%	17%	50%	100%	17%	0%	0%	0%	33%	0%		
ONE VEHICLE	PED/BIKE	DAY	NIGHT	WET	DRY	EXCESS SPEED	FTY R/W	DUI			
3	0	7	0	2	4	0	1	0			
50%	0%	117%	0%	33%	67%	0%	17%	0%			
TOTAL VEHICLES ENTERING/ADT:						CRASH RATE:			MEV

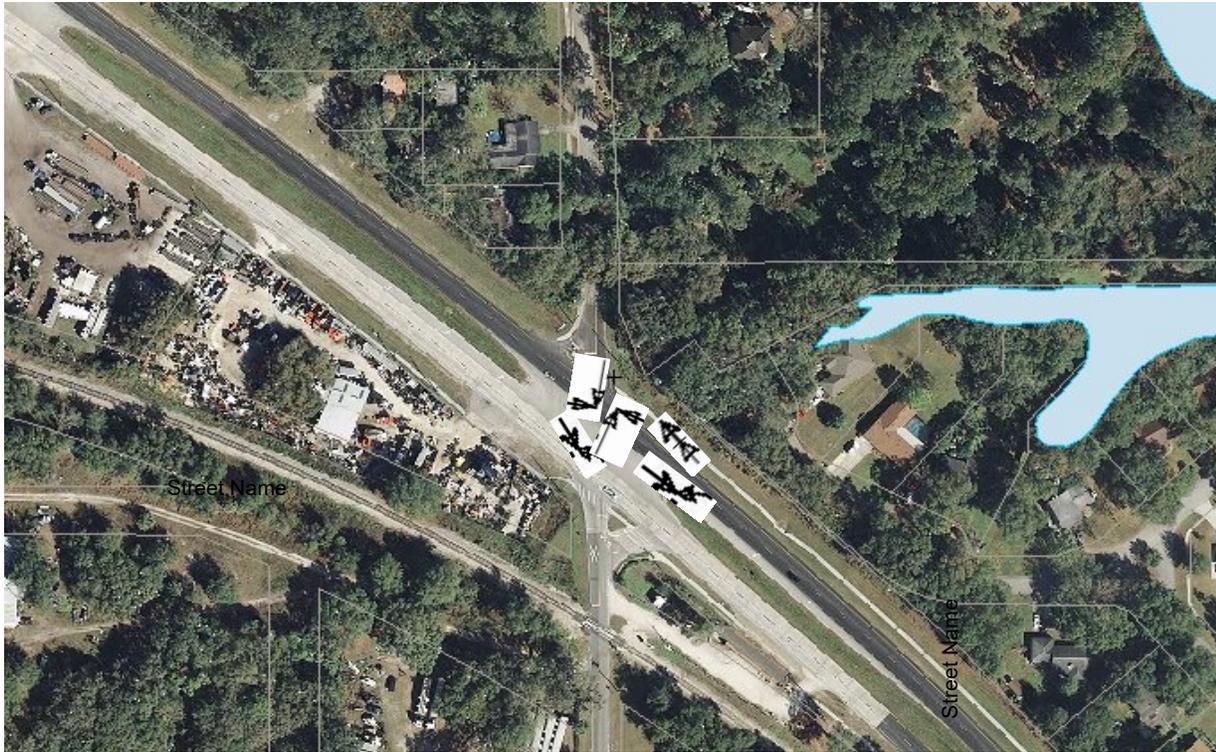
Seven crashes were reported at the intersection of Laughlin Road and US 441. The following pages include a detailed summary of the crashes at this skewed intersection and a collision diagram to show the approximate location and types of crashes. Fifty-seven percent of crashes were left turn crashes and 86 percent were caused by a failure to yield right of way.

Crash Summary											
Location: US 441						Intersection Control: stop control on Laughlin					
Intersecting Route: Laughlin Road						M.P.:		Engineer: CNL			
Study Period From: 2006						To: 2008		County: Orange			
NO.	DATE	DAY	TIME	TYPE	FATAL	INJURY	PROPERTY DAMAGE	DAY/NIGHT	WET/DRY	CONTRIBUTING CAUSE	ACCIDENT REPORT #
1	2/10/2006	Fri	1:38 PM	Left Turn	No	Yes	\$3,000	Day	Dry	Failure to Yield R/W	FHPD06OFF014464
2	10/3/2006	Tue	6:16 PM	Right angle	No	Yes	\$4,000	Day	Dry	Failure to Yield R/W	FHPD06OFF106076
3	4/14/2007	Sat	11:38 AM	Left Turn	No	No	\$13,000	Day	Dry	Failure to Yield R/W; unlicensed driver	FHPD07OFF038617
4	4/30/2007	Mon	11:47 AM	Rear End	No	No	\$5,500	Day	Dry	Failure to Yield R/W (vehicle not in collision); careless (collision)	FHPD07OFF044324
5	5/29/2007	Tue	7:06 AM	Left Turn	No	Yes	\$19,300	Day	Dry	Failure to Yield R/W	FHPD07OFF054594
6	9/25/2007	Tue	7:46 AM	Right angle	No	Yes	\$8,000	Day	Dry	Careless Driving	FHPD07OFF099221

7	8/12/2008	Tue	3:13 PM	Left Turn	No	Yes	\$15,000	Day	Wet	Failure to Yield R/W	FHPD08OFF076890
TOTAL											
TOTAL NO.	FATAL	INJURY	PROPERTY DAMAGE	ANGLE	LEFT TURN	RIGHT TURN	REAR END	SIDE SWIPE	HEAD ON		
7	0	5	7	2	4	0	1	0	0		
%	0%	71%	100%	29%	57%	0%	14%	0%	0%		
ONE VEHICLE	PED/BIKE	DAY	NIGHT	WET	DRY	EXCESS SPEED	FTY R/W	DUI			
0	0	7	0	1	6	0	6	0			
	0%	100%	0%	14%	86%	0%	86%	0%			
TOTAL VEHICLES ENTERING/ADT:						CRASH RATE:			MEV
