**TEXAS-AMERICANA
ROAD SAFETY SMALL AREA STUDY
ORANGE COUNTY DISTRICT 6**

**PUBLIC WORKS DEPARTMENT
TRAFFIC ENGINEERING DIVISION**

FEBRUARY 2015

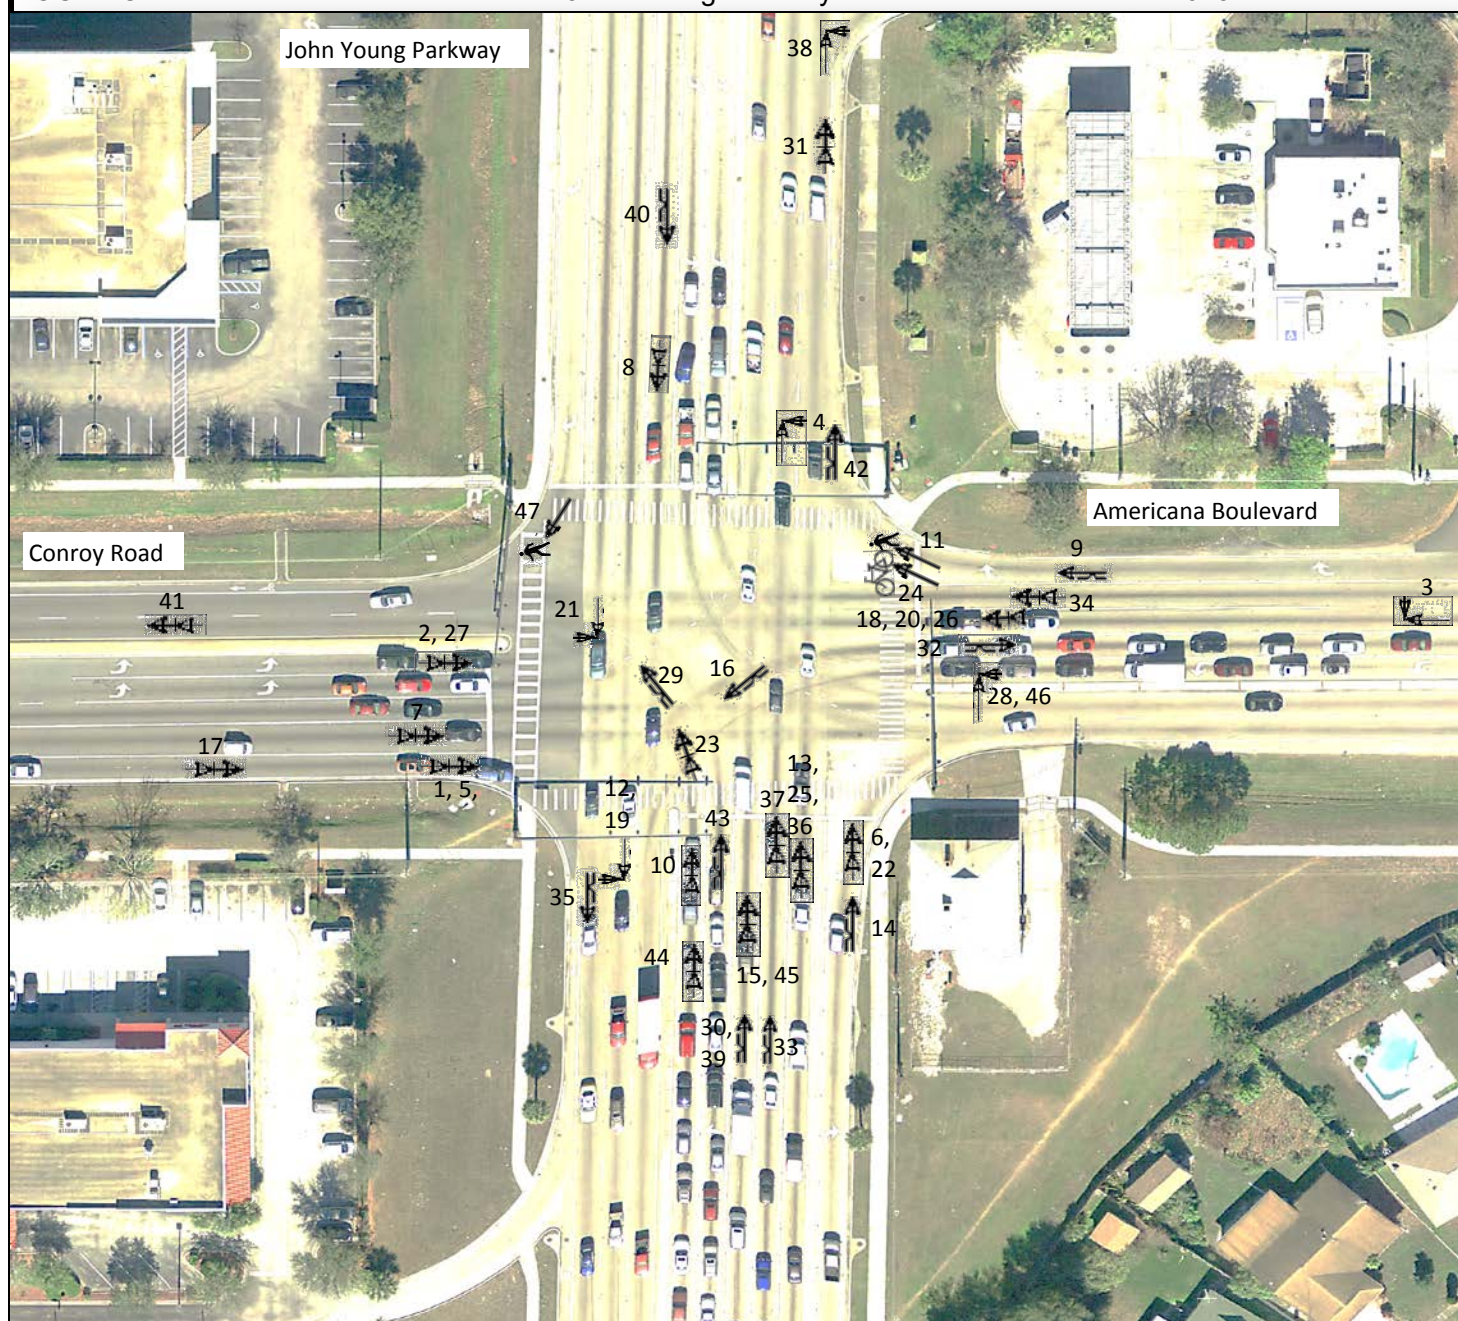
LOCATION: Americana Boulevard at John Young Parkway

Crash Summary											
Location:		AMERICANA BOULEVARD					Intersection Control: Signalized				
Intersecting Route:		JOHN YOUNG PARKWAY					Prepared by: CNL				
Study Period From:		2013					County: Orange				
NO	DATE	DAY	TIME	TYPE	FATAL	INJURY	PROPERTY DAMAGE	WEATHER	DAY/NIGHT	CONTRIBUTING CAUSE	ACCIDENT REPORT #
1	1/19/2013	Sat	4:49 PM	Rear End	No	No	\$663	Clear	Daylight	Careless Driving	FHPD13OFF005275
2	2/23/2013	Sat	3:55 AM	Rear End	No	No	\$1,100	Clear	Dark - Lighted	Following Too Close	2013-00080301
3	3/5/2013	Tue	6:50 PM	Right Turn	No	Yes	\$3,000	Clear	Dark - Lighted	Ran Stop Sign	FHPD13OFF018205
4	3/18/2013	Mon	11:08 AM	Angle	No	No	\$6,000	Clear	Daylight	Failure to Obey Signal	FHPD13OFF022205
5	3/19/2013	Tue	1:45 PM	Rear End	No	No	\$2,000	Clear	Daylight	Careless Driving	FHPD13OFF022512
6	3/26/2013	Tue	6:56 PM	Rear End	No	No	\$2,500	Clear	Dusk	Careless Driving	FHPD13OFF024817
7	4/1/2013	Mon	5:03 PM	Rear End	No	No	\$1,900	Clear	Daylight	Careless Driving	FHPD13OFF026538

TOTAL											
TOTAL NO		FATAL	INJURY	PDO	ANGLE	LEFT	RIGHT	REAR END	SIDE SWIPE	HEAD ON	IMPROPER LANE CHANGE
	47	0	11	36	4	1	3	24	11	0	4
	%	0%	23%	77%	9%	2%	6%	51%	23%	0%	9%
ONE VEHICLE		PED/BIKE	DAY	DUSK/NIGHT	WET	DRY	SPEEDING	FTY R/W	ALCOHOL/DRUGS	DISTRACTED	FAIL TO OBEY SIGNAL
	0	2	30	17	3	44	0	3	2	20	3
	0%	4%	64%	36%	6%	94%	0%	6%	4%	43%	6%

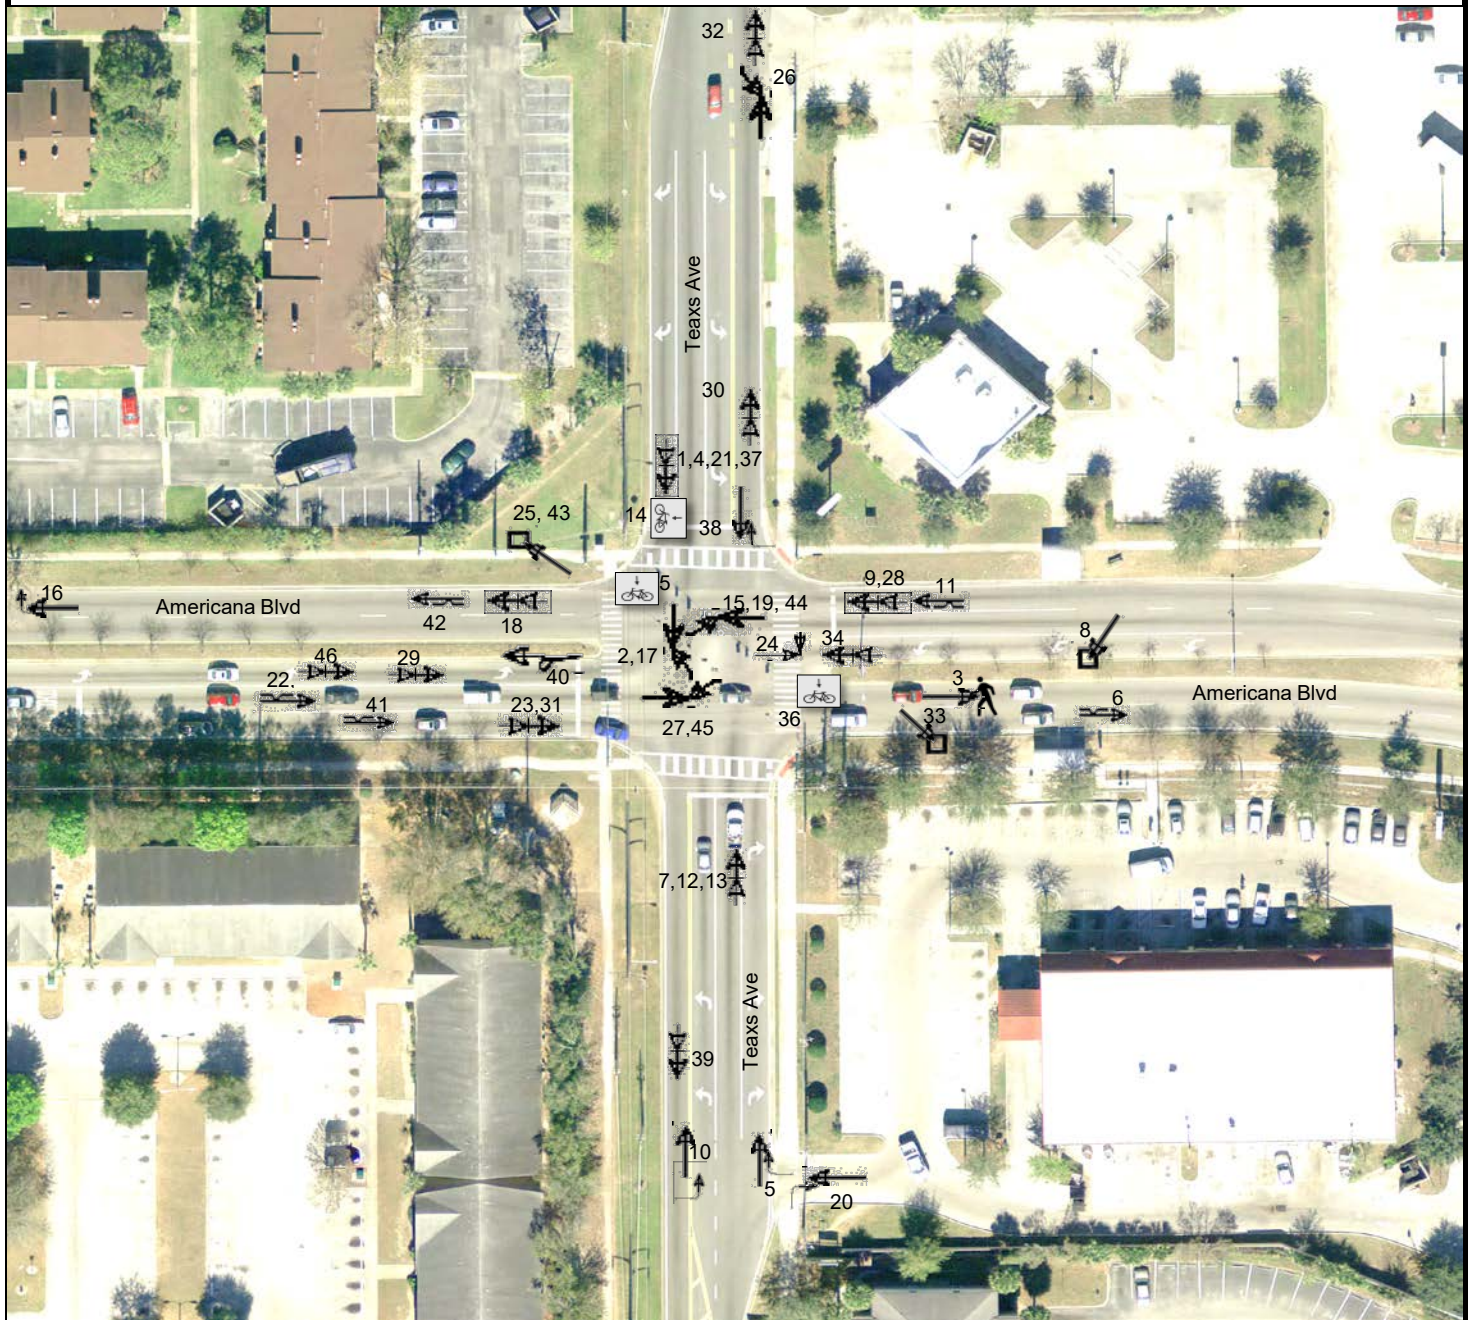
LOCATION: Americana Boulevard and Texas Avenue

Crash Summary											
Location:		AMERICANA BOULEVARD					Intersection Control: Signalized				
Intersecting Route:		TEXAS AVENUE					Prepared by: CNL				
Study Period From:		2013					County: Orange				
NO	DATE	DAY	TIME	TYPE	FATAL	INJURY	PROPERTY DAMAGE	WEATHER	DAY/NIGHT	CONTRIBUTING CAUSE	ACCIDENT REPORT #
1	1/10/2013	Thu	3:02 PM	Rear End	No	Yes	\$1,000	Clear	Daylight	Careless Driving	FHPD13OFF002735
2	1/22/2013	Tue	9:56 PM	Left Turn	No	No	\$4,000	Clear	Dark - Lighted	FTY R/W	FHPD13OFF006066
3	1/30/2013	Wed	8:41 AM	Pedestrian	No	Yes	\$0	Clear	Daylight	Ped--Jay Walking	FHPD13OFF007952
4	1/30/2013	Wed	8:45 AM	Rear End	No	No	\$5,000	Clear	Daylight	Careless Driving	FHPD13OFF007955
5	2/3/2013	Sun	1:00 PM	Right Turn	No	No	\$7,000	Clear	Daylight	FTY R/W	FHPD13OFF009182
6	2/6/2013	Wed	4:45 PM	Sideswipe	No	No	\$1,100	Clear	Daylight	Improper Lane Change	FHPD13OFF01006
7	2/19/2013	Tue	11:24 AM	Rear End	No	No	\$0	Clear	Daylight	Careless Driving	FHPD13OFF013787

46	0	15	31	2	10	2	18	5	0	3
	%	0%	33%	67%	4%	22%	4%	39%	11%	0%	7%
ONE VEHICLE		PED/BIKE	DAY	DUSK/NIGHT	WET	DRY	SPEEDING	FTY R/W	ALCOHOL/DRUGS	DISTRACTED	FAIL TO OBEY SIGNAL
	4	4	31	15	3	43	0	13	0	13	1
	9%	9%	67%	33%	7%	93%	0%	28%	0%	28%	2%

At the intersection of Americana Boulevard and Texas Avenue it is recommended that the signal be reconstructed due to its age and a leaning signal pole in the northwest corner. In order to address the high crash rate and red light running at the intersection, with the reconstruction of this intersection signal head backplates will be installed to increase the visibility of signal head indications in the eastbound and westbound directions. Sidewalk curb ramps and pedestrian pushbuttons and signing will be upgraded to meet current ADA requirements.

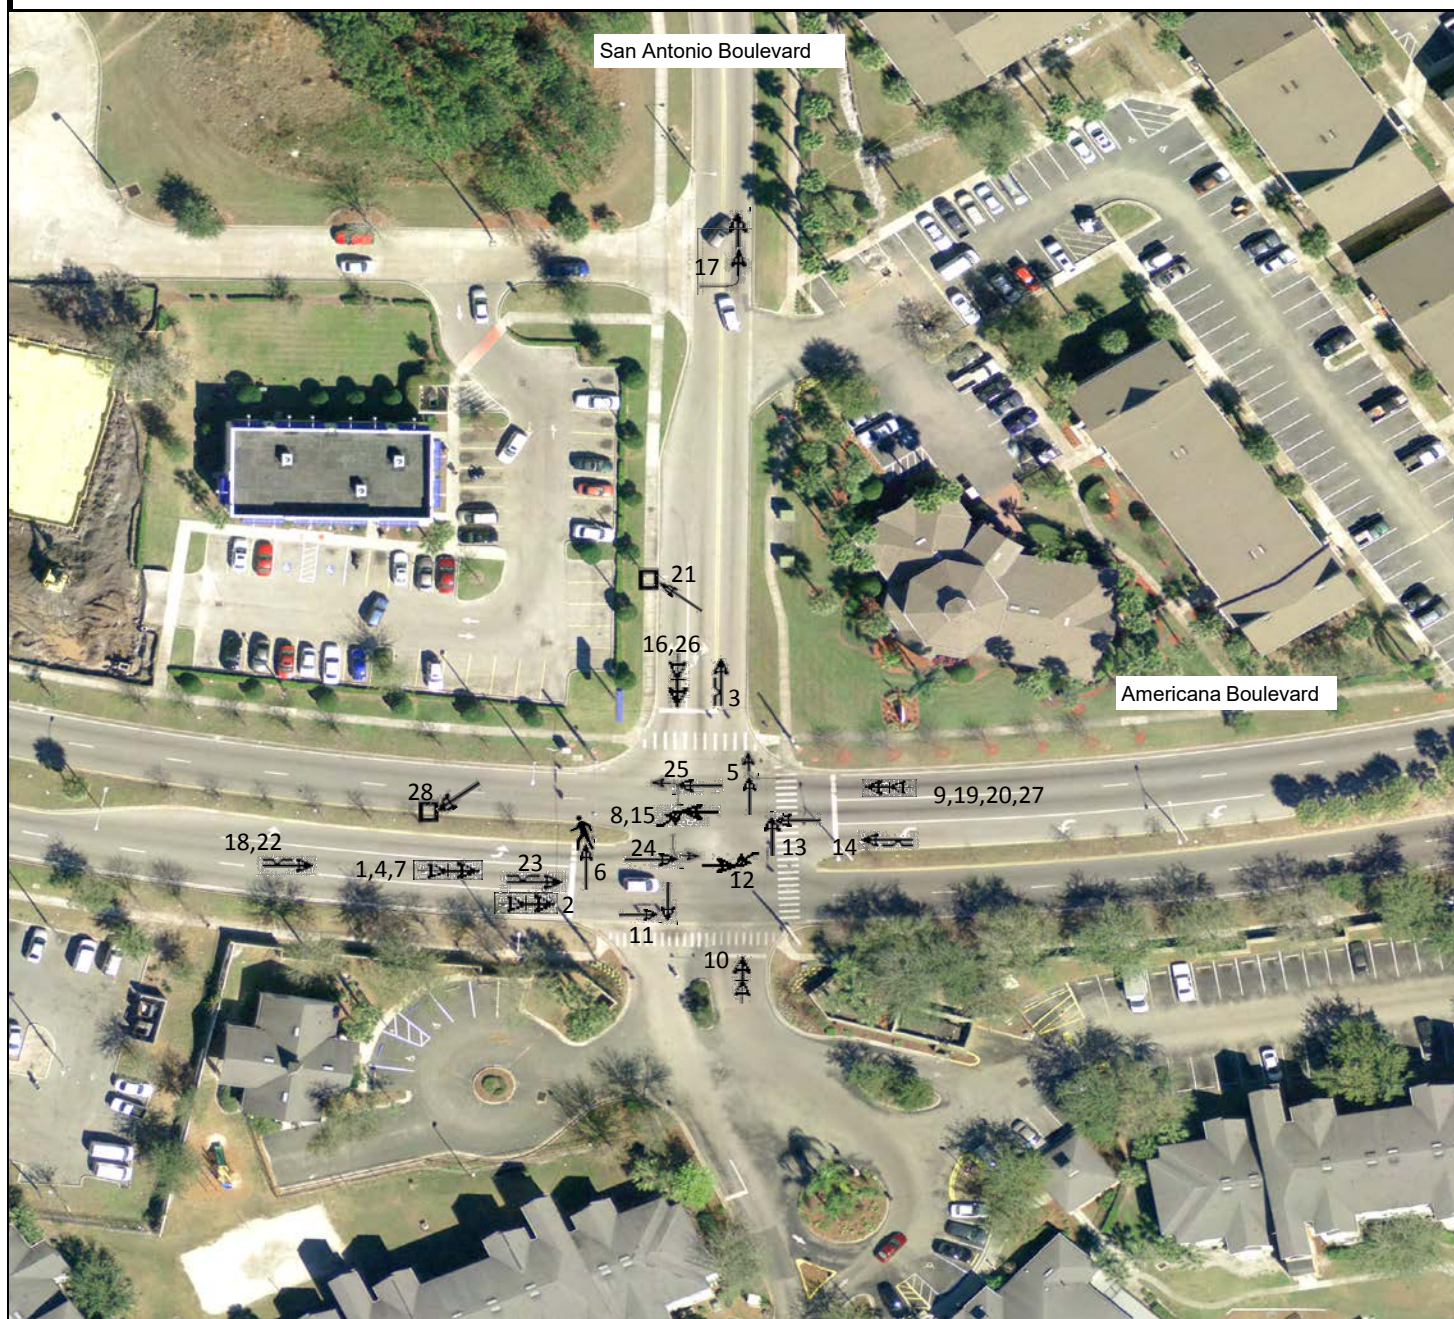
LOCATION: Americana Boulevard at San Antonio Boulevard

Crash Summary											
Location:		AMERICANA BOULEVARD						Intersection Control: Signalized			
Intersecting Route:		SAN ANTONIO AVENUE						Prepared by: CNL			
Study Period From:		2011 - 2013						County: Orange			
NO	DATE	DAY	TIME	TYPE	FATAL	INJURY	PROPERTY DAMAGE	WEATHER	DAY/NIGHT	CONTRIBUTING CAUSE	ACCIDENT REPORT #
1	1/25/2011	Tue	7:54 AM	Rear End	No	Yes	\$3,500	Clear	Daylight	Careless Driving	FHPD11OFF006521
2	2/9/2011	Wed	9:30 AM	Rear End	No	Yes	\$4,500	Clear	Daylight	Careless Driving	FHPD11OFF010732
3	2/28/2011	Mon	4:20 PM	Sideswipe	No	No	\$800	Clear	Daylight	Careless Driving	FHPD11OFF016571
4	5/7/2011	Sat	4:56 PM	Rear End	No	No	\$2,250	Clear	Daylight	Careless Driving	FHPD11OFF037581
5	5/23/2011	Mon	7:46 AM	Right Turn	No	No	\$1,000	Clear	Daylight	Failure to Yield ROW	FHPD11OFF041963
6	5/24/2011	Tue	3:23 PM	Pedestrian	No	Yes	\$25	Clear	Daylight	Careless Driving	FHPD11OFF042350
7	6/1/2011	Wed	2:40 PM	Rear End	No	No	\$200	Clear	Daylight	Careless Driving	FHPD11OFF044785

28	11/2/2013	Sat	9:50 AM	Off Road	No	No	\$600	Cloudy	Daylight	Careless Driving	FHPD13OFF093799
TOTAL NO		FATAL	INJURY	PDO	ANGLE	LEFT	RIGHT	REAR END	SIDE SWIPE	HEAD ON	IMPROPER LANE CHANGE
		28	0	5	23	2	6	1	9	4	1
		%	0%	18%	82%	7%	21%	4%	32%	14%	4%
ONE VEHICLE		PED/BIKE	DAY	DUSK/NIGHT	WET	DRY	SPEEDING	FTY R/W	ALCOHOL/DRUGS	DISTRACTED	FAIL TO OBEY SIGNAL
		1	1	18	10	0	28	0	5	2	4
		4%	4%	64%	36%	0%	100%	0%	18%	7%	14%

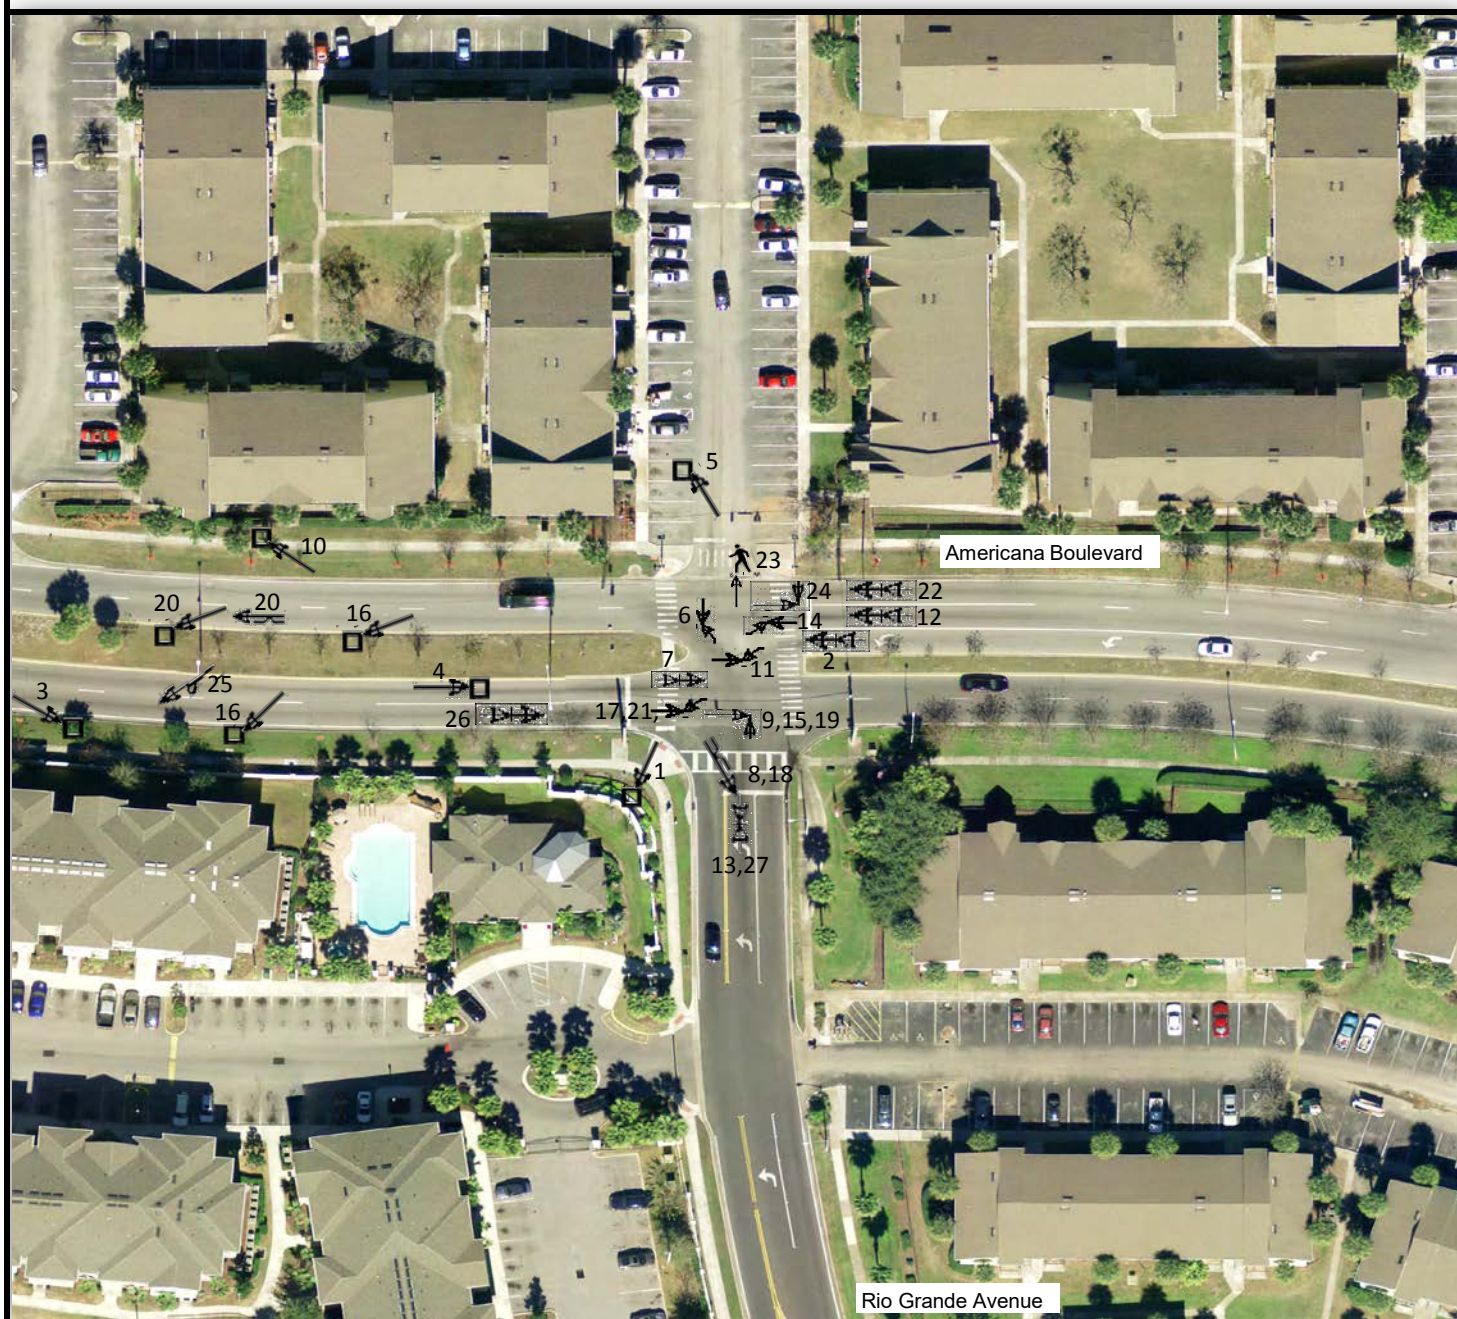
LOCATION: Americana Boulevard at Rio Grande Avenue

Crash Summary											
Location:		AMERICANA BOULEVARD						Intersection Control: Signalized			
Intersecting Route:		S RIO GRANDE AVENUE						Prepared by: CNL			
Study Period From:		2011 - 2013						County: Orange			
NO	DATE	DAY	TIME	TYPE	FATAL	INJURY	PROPERTY DAMAGE	WEATHER	DAY/NIGHT	CONTRIBUTING CAUSE	ACCIDENT REPORT #
1	1/26/2011	Wed	2:00 AM	Off Road	No	No	\$250	Rain	Dark - Lighted	Unknown	FHPD11OFF006757
2	3/5/2011	Sat	11:26 AM	Rear End	No	Yes	\$150	Clear	Daylight	Unknown	FHPD11OFF018125
3	3/9/2011	Wed	10:50 AM	Off Road	No	Yes	\$2,000	Clear	Daylight	Unknown	FHPD11OFF019267
4	4/6/2011	Wed	2:16 PM	Other	No	No	\$2,500	Clear	Daylight	Unknown	FHPD11OFF028335
5	4/15/2011	Fri	12:05 AM	Other	No	No	\$15,000	Clear	Dark - Lighted	Unknown	FHPD11OFF030895
6	5/17/2011	Tue	8:56 PM	Angle	No	Yes	\$6,000	Clear	Dark - Lighted	Fail to Yield ROW	FHPD11OFF040554
7	7/27/2011	Wed	6:28 PM	Rear End	No	No	\$1,300	Rain	Daylight	Careless Driving	ORCC11OFF000947

TOTAL											
TOTAL NO		FATAL	INJURY	PDO	ANGLE	LEFT	RIGHT	REAR END	SIDE SWIPE	HEAD ON	IMPROPER LANE CHANGE
		27	0	9	18	4	5	0	5	3	2
		%	0%	33%	67%	15%	19%	0%	19%	11%	7%
ONE VEHICLE		PED/BIKE	DAY	DUSK/NIGH	WET	DRY	SPEEDING	FTY R/W	ALCOHOL/DRUGS	DISTRACTED	FAIL TO OBEY SIGNAL
		5	1	19	4	23	0	4	0	6	3
		19%	4%	70%	30	15	85%	0%	15%	0%	22%

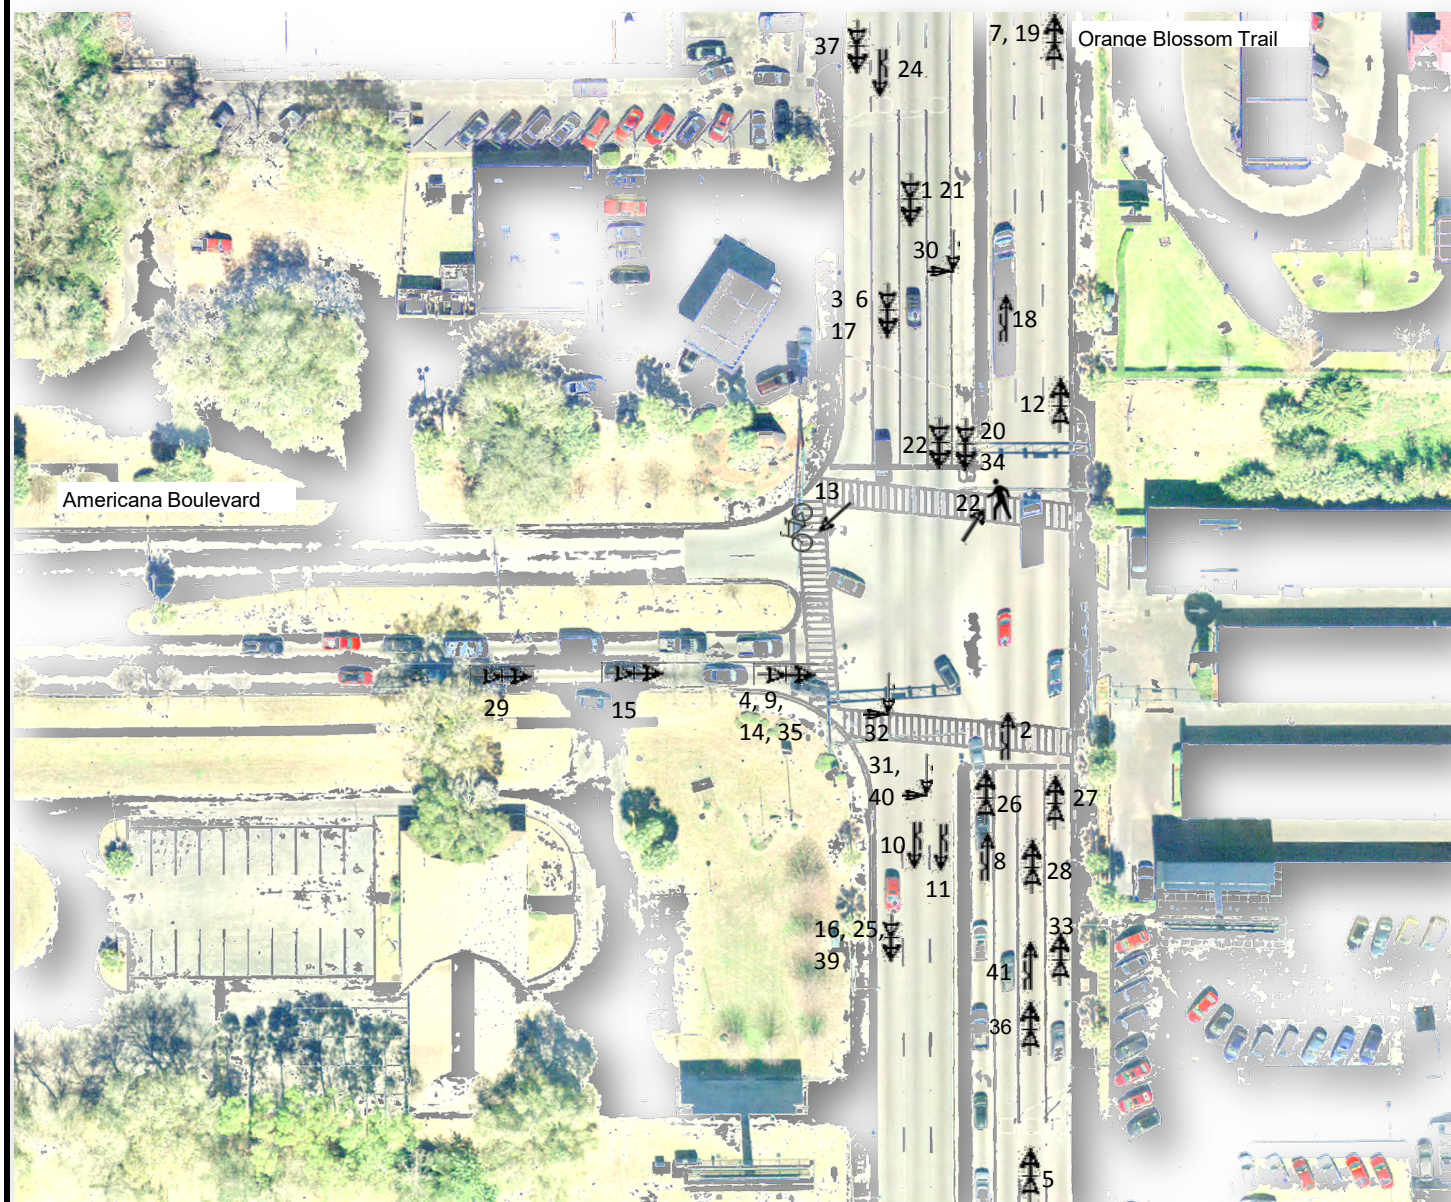
LOCATION: Americana Boulevard at Orange Blossom Trail

Crash Summary											
Location:		AMERICANA BOULEVARD						Intersection Control: Signalized			
Intersecting Route:		ORANGE BLOSSOM TRAIL (US 441)						Prepared by: CNL			
Study Period From:		2013						County: Orange			
NO	DATE	DAY	TIME	TYPE	FATAL	INJURY	PROPERTY DAMAGE	WEATHER	DAY/NIGHT	CONTRIBUTING CAUSE	ACCIDENT REPORT #
1	1/26/2013	Sat	12:34 PM	Sideswipe	No	Yes	\$500	Clear	Daylight	Unknown	FHPD13OFF007017
2	1/28/2013	Mon	12:36 PM	Sideswipe	No	No	\$600	Clear	Daylight	Unknown	FHPD13OFF007502
3	2/11/2013	Mon	8:20 AM	Rear End	No	No	\$792	Clear	Daylight	Careless Driving	FHPD13OFF011358
4	2/13/2013	Wed	12:57 PM	Rear End	No	No	\$250	Clear	Daylight	Careless Driving	FHPD13OFF011977
5	2/23/2013	Sat	7:51 PM	Rear End	No	No	\$400	Clear	Dark - Lighted	Unknown	FHPD13OFF015167
6	3/6/2013	Wed	9:16 AM	Rear End	No	No	\$4,000	Clear	Daylight	Careless Driving	FHPD13OFF018311
7	3/6/2013	Wed	3:05 PM	Rear End	No	No	\$12,700	Clear	Daylight	Careless Driving	FHPD13OFF018403

38	12/4/2013	Wed	3:35 PM	Sideswipe	No	No	\$200	Clear	Daylight	Careless Driving	FHPD13OFF103554
39	12/10/2013	Tue	11:49 AM	Rear End	No	No	\$3,000	Clear	Daylight	Unknown	FHPD13OFF105149
40	12/25/2013	Wed	3:20 AM	Right Turn	No	No	\$5,000	Clear	Dark - Lighted	Fail to Obey Signal	FHPD13OFF109909
41	12/26/2013	Thu	3:55 PM	Sideswipe	No	No	\$300	Clear	Daylight	Unknown	FHPD13OFF110266
TOTAL											
TOTAL NO		FATAL	INJURY	PDO	ANGLE	LEFT	RIGHT	REAR END	SIDE SWIPE	HEAD ON	IMPROPER LANE CHANGE
		41	0	1	2	0	2	26	9	0	3
		%	0%	29%	71	0%	0%	5%	63%	22%	7%
ONE VEHICLE		PED/BIKE	DAY	DUSK/NIGHT	WET	DRY	SPEEDING	FTY R/W	ALCOHOL/DRUGS	DISTRACTED	FAIL TO OBEY SIGNAL
		0	2	27	14	2	39	0	2	1	13
		0%	5%	66%	34%	5%	95%	0%	5%	2%	32%

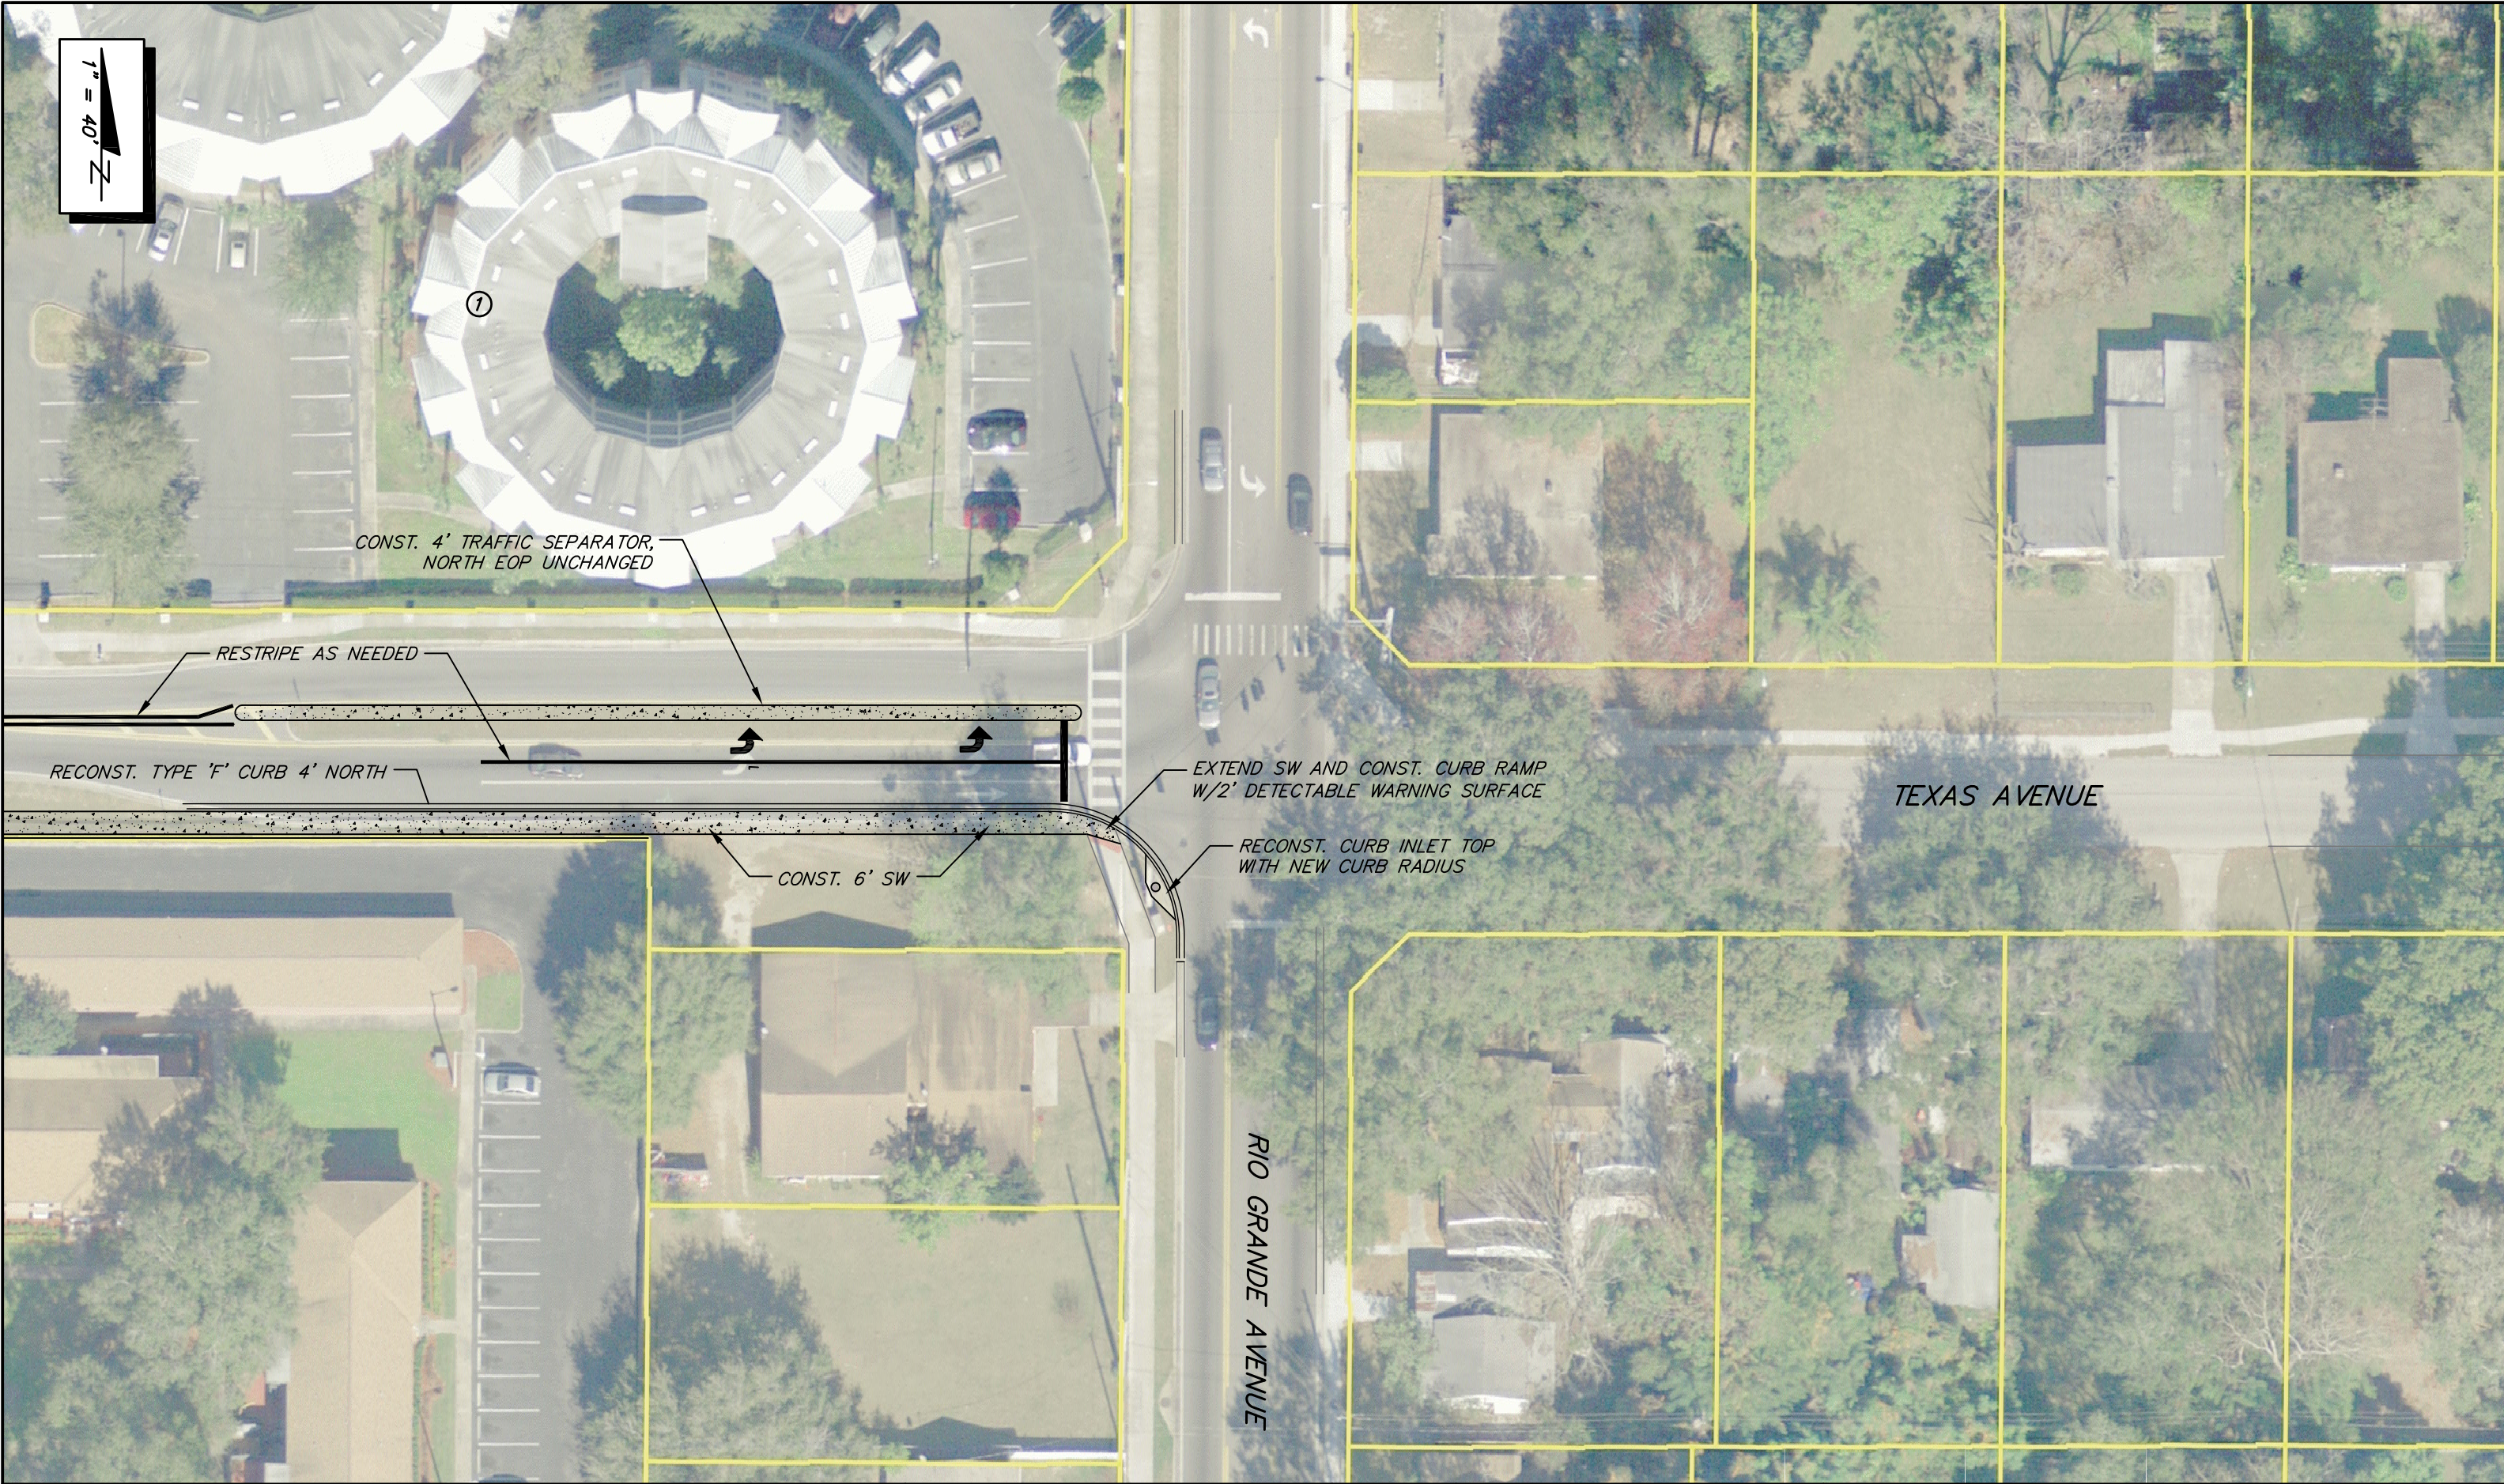
AMERICANA BOULEVARD
PEDESTRIAN SAFETY
IMPROVEMENTS

An item believed to be a high priority is related to the amount of pedestrians crossing Americana Boulevard at uncontrolled mid-block locations between Texas Avenue and San Antonio Avenue. It is recommended that two mid-block crosswalks with rectangular rapid flashing beacons (RRFBs) be installed and that pedestrian channelization barrier be considered for installation in the median. A crosswalk and signalized pedestrian crossing for the west leg of the San Antonio Avenue intersection is

also recommended to provide an additional safe pedestrian crossing location. See depiction of recommended improvements, page 83.

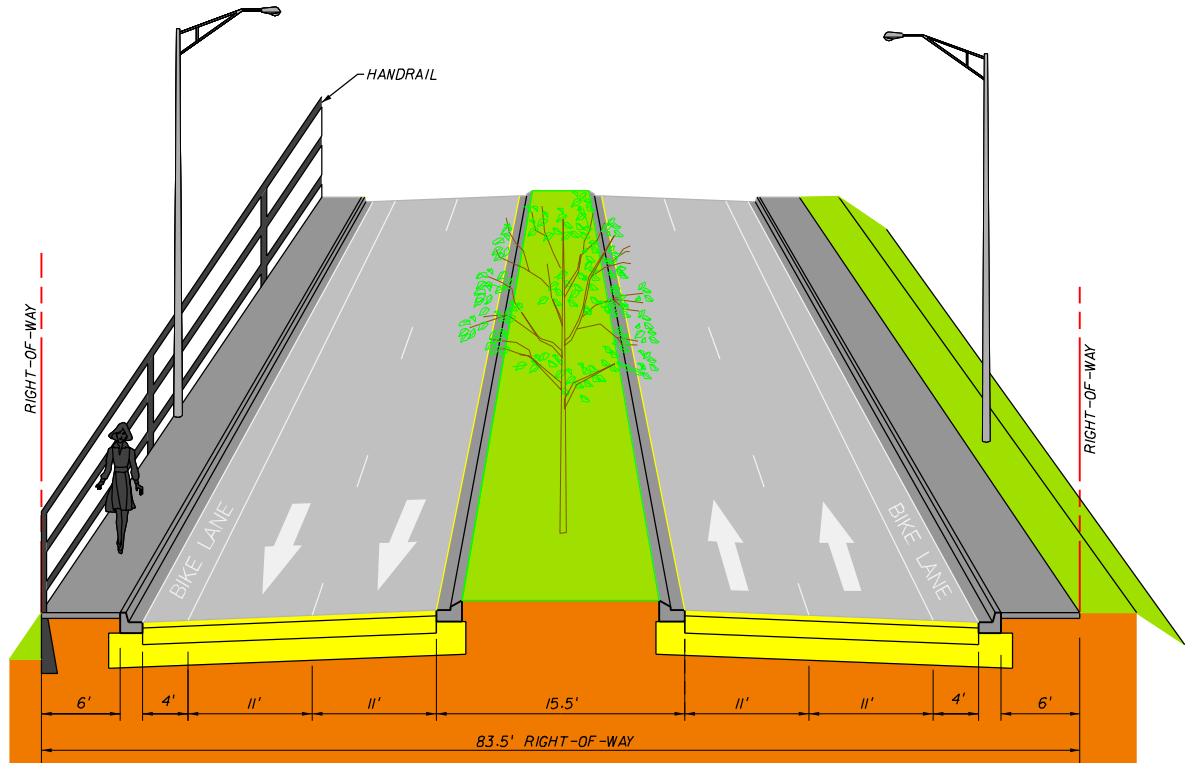
HOLDEN AVENUE

**RAISED MEDIAN
DESIGN SPEED 45 MPH**

TEXAS AVENUE TO RIO GRANDE AVENUE
